## **DECEMBER 2015 INSPECTION CCR LANDFILL TS POWER PLANT**

**Newmont Nevada Energy Investment, LLC  
914 Dunphy Ranch Road  
Battle Mountain, Nevada 89820**

**NewFields Mining Design & Technical Services  
1301 N. McCarran Blvd., Suite 101  
Sparks, Nevada 89431**

**NewFields Project 475.0221  
January 2016**

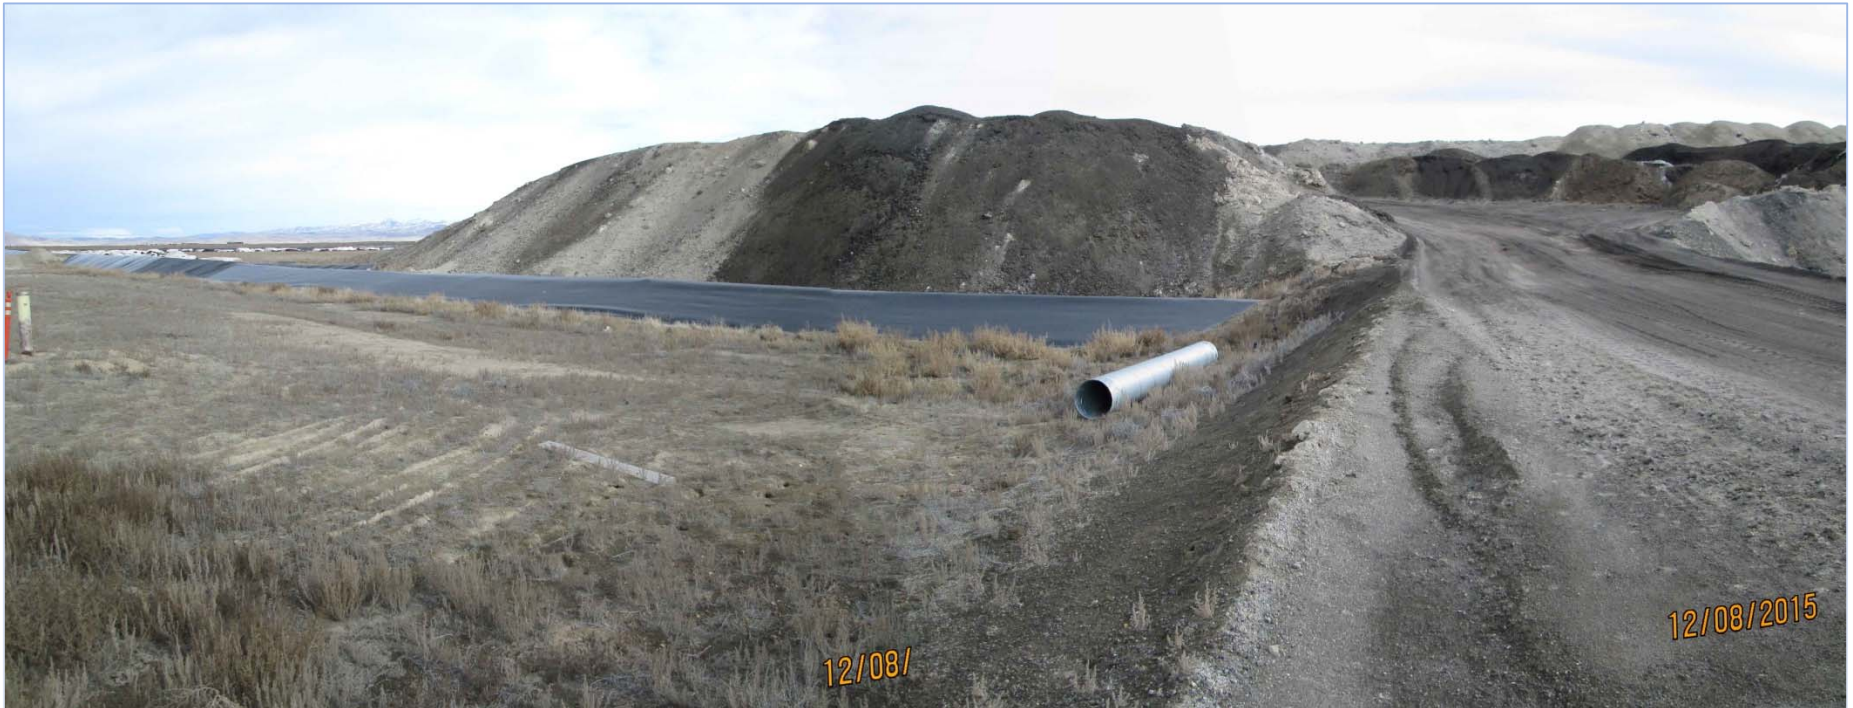
The materials placed within the landfill are predominantly contained within Cell 1 to an approximate height of 20 feet. Placement of material is proceeding to the north into Cell 2. Materials have been placed with approximate angle of repose slopes and some isolated areas with minor raveling or sloughing of overly wet materials was evident (Photographs 33, 34, 35 and 43). Photographs 2-3, 24, 37, 53-57 and 67-68 show typical conditions of the materials contained within the landfill.

**Panoramic Photographs 0002-003:** West side of Cell1 with access ramp. TSMW3 is visible on left.

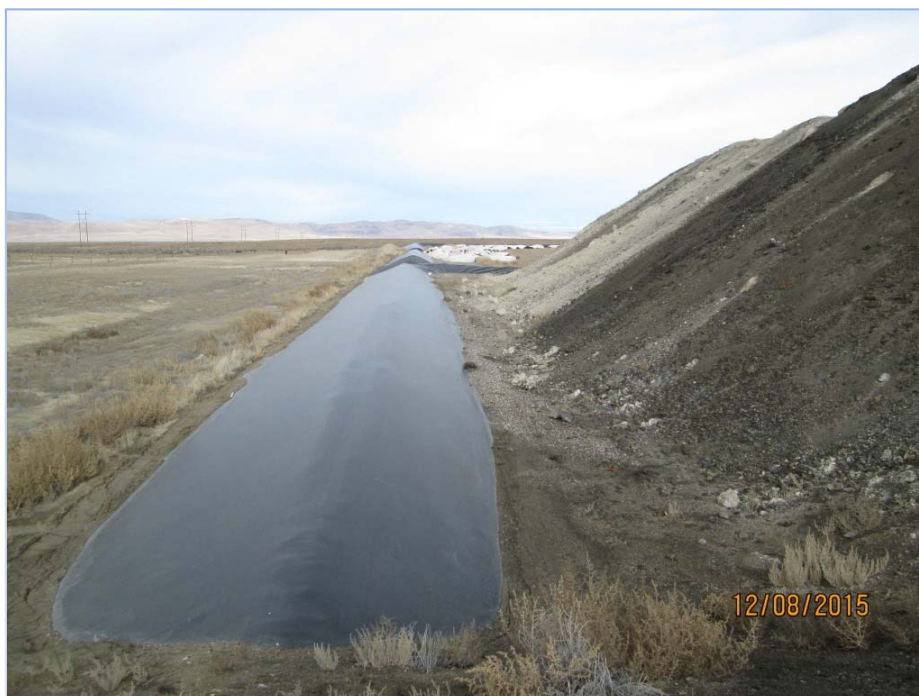
The entire perimeter of the facility was toured as part of the inspection and appeared to be in good to excellent condition. Photographs 2, 4, 7, 12, 13, 18, 20, 30, 32, 35, and 47 are illustrative of typical conditions along the facility perimeter. The perimeter containment berms were observed to be well constructed and the HDPE liner is exposed and appears to be in excellent condition. No signs of damage to the lining system were noted during the inspection. General housekeeping practices around and within the facility were good and the facility appeared to be well maintained.

**Photograph 0004:** West side of Cell 1 north of access ramp (looking north).

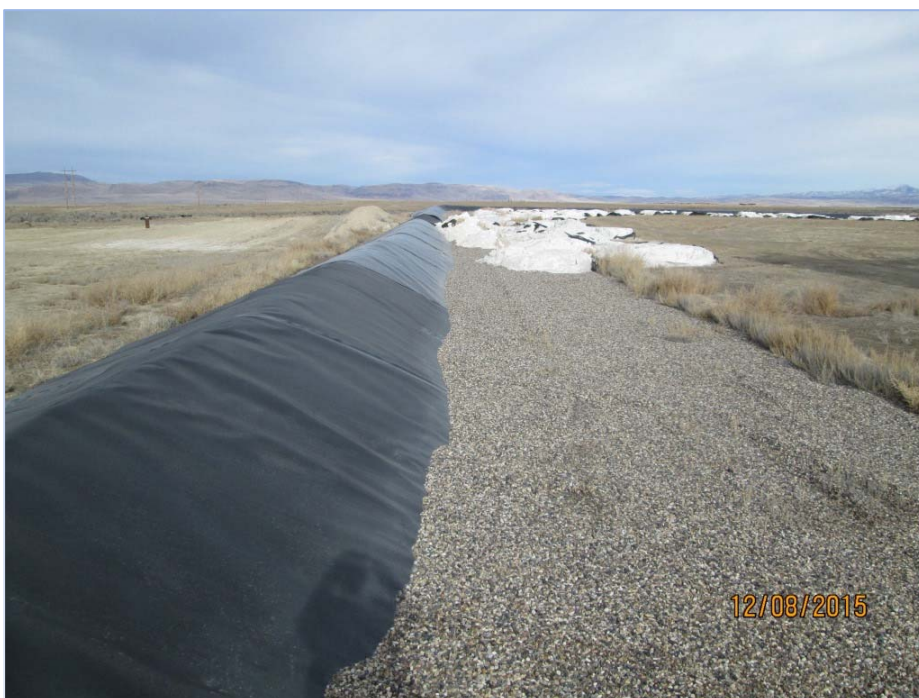
**Photograph 0007:** West side of Cell 2 (looking north).

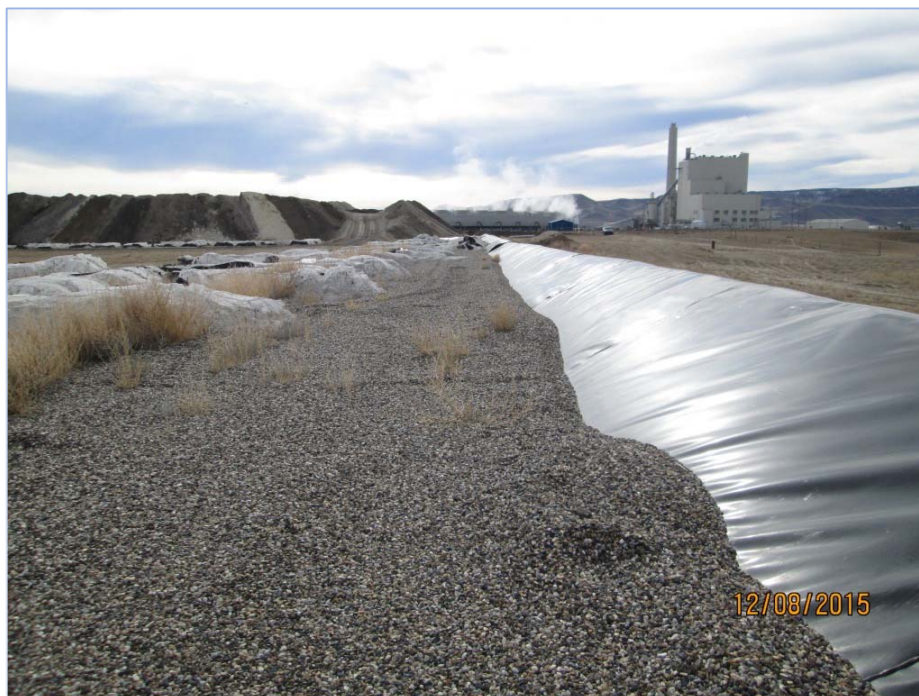
**Photograph 0012:** West side of Cell 2 near northwest corner (looking south).

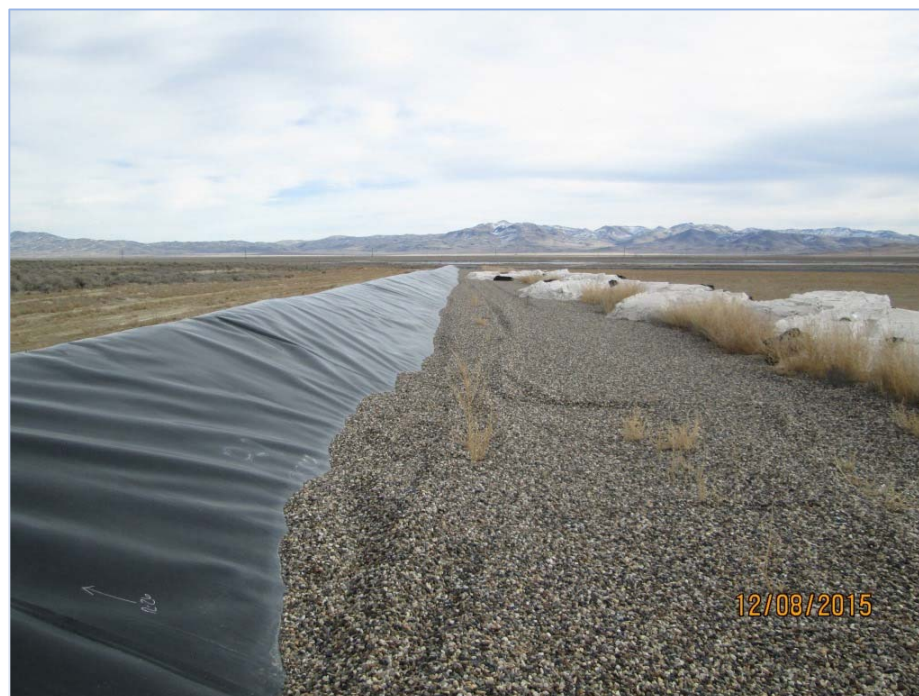
**Photograph 0013:** Northwest corner of Cell 2 (looking east).

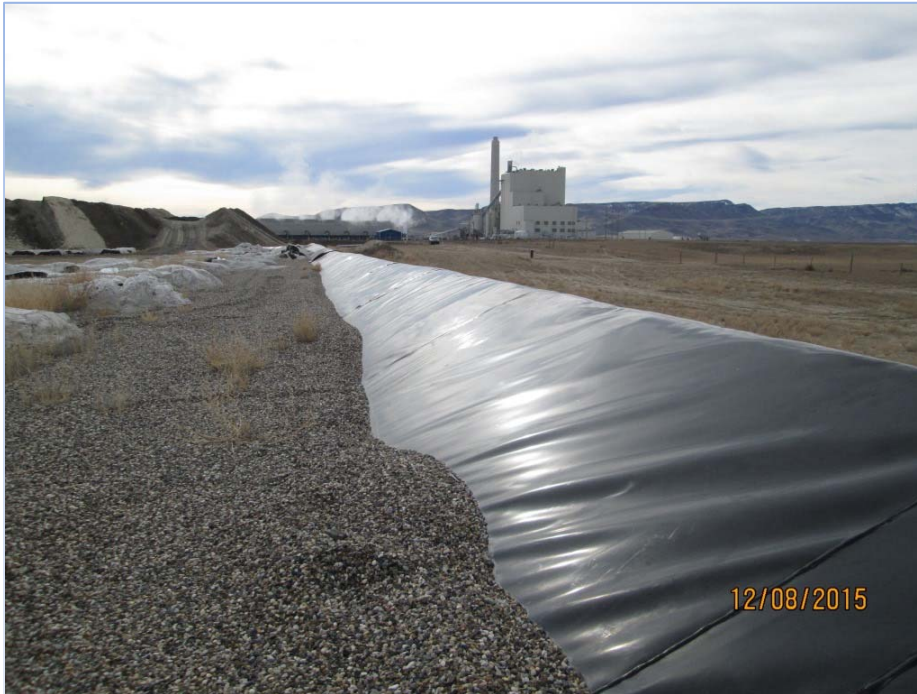
**Photograph 0016:** Northwest corner of Cell 2 (looking east).

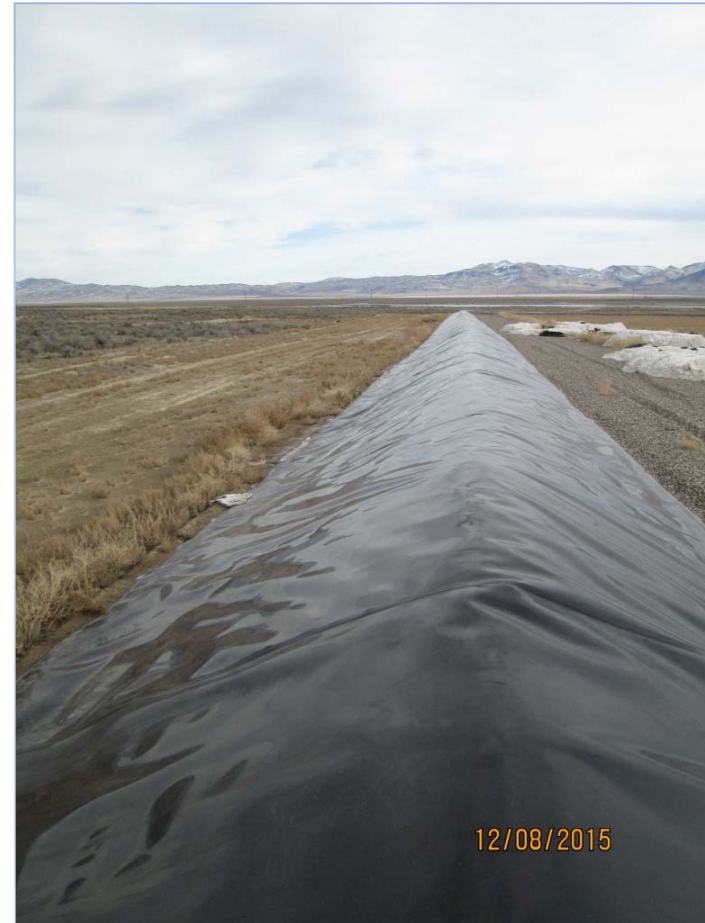
Stormwater is routed around the perimeter of the facility by diversion channels and/or the perimeter berms that surround the landfill. Typical diversions are shown in Photographs 17, 22, 44, 50, 51 and 72. An access ramp over the perimeter berm is located near the southwest corner of Cell 1 and a culvert (Photographs 50 and 51) was noted beneath the ramp to convey runoff around the facility. Stormwater controls were observed to be consistent with the intent of the design and no issues were noted as part of the inspection.

**Photograph 0017:** North perimeter berm along edge of Cell 2.

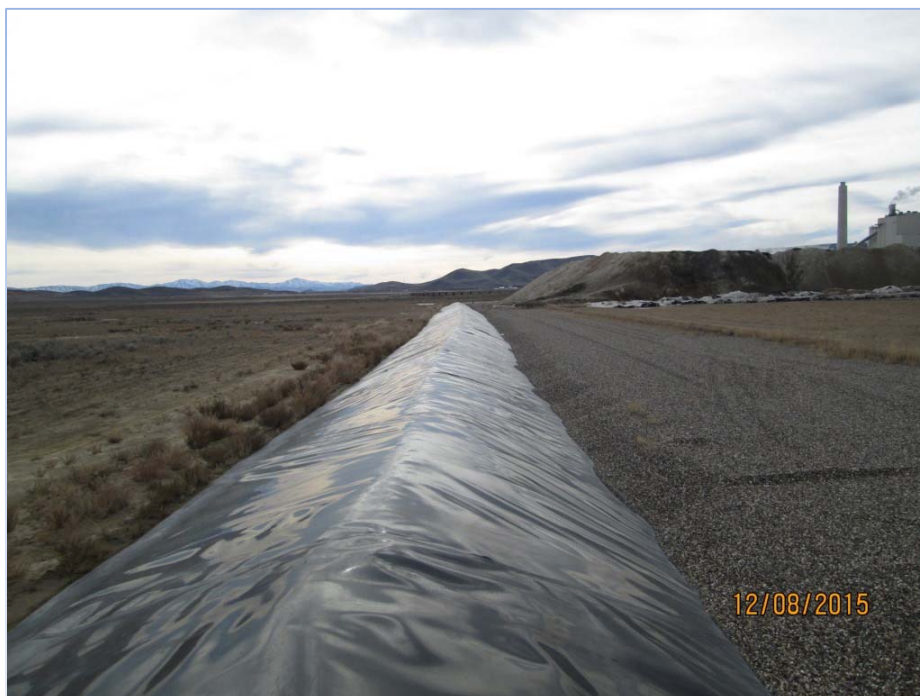
**Photograph 0018:** Northeast corner of Cell 2 (looking south).

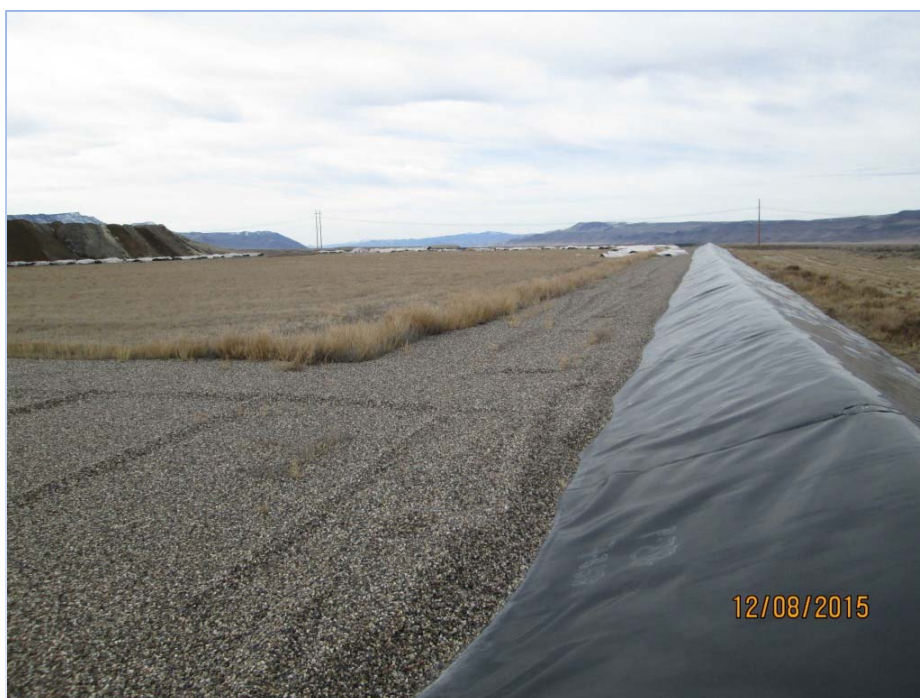
**Photograph 0020:** Northeast corner of Cell 2 (looking west).

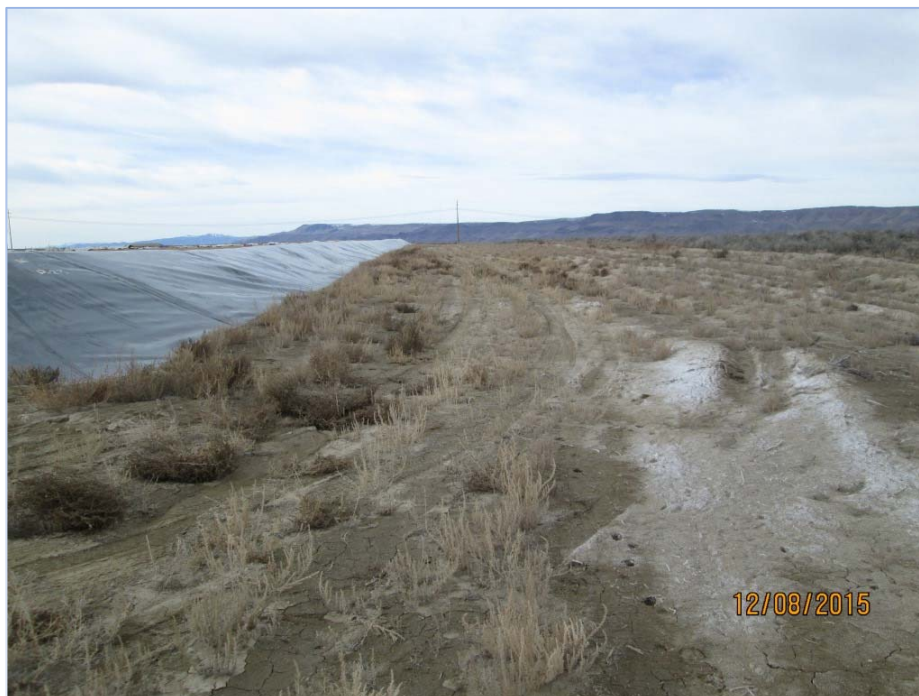
**Photograph 0022:** Stormwater diversion swale at north side of Cell 2 (looking west).

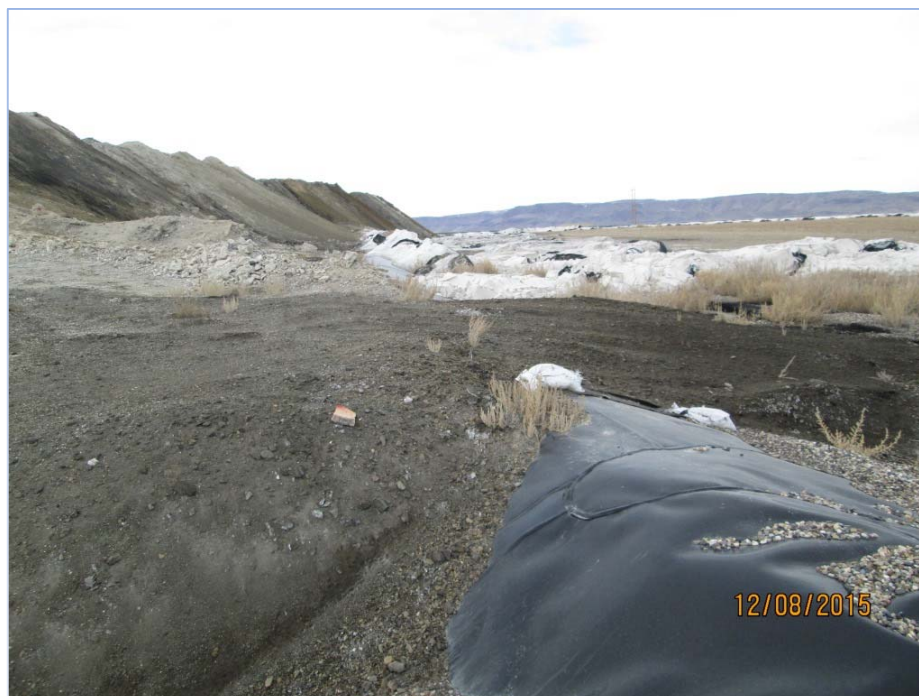
**Photograph 0024:** Southeast corner of Cell 2 at Cell 1-2 berm (looking west).

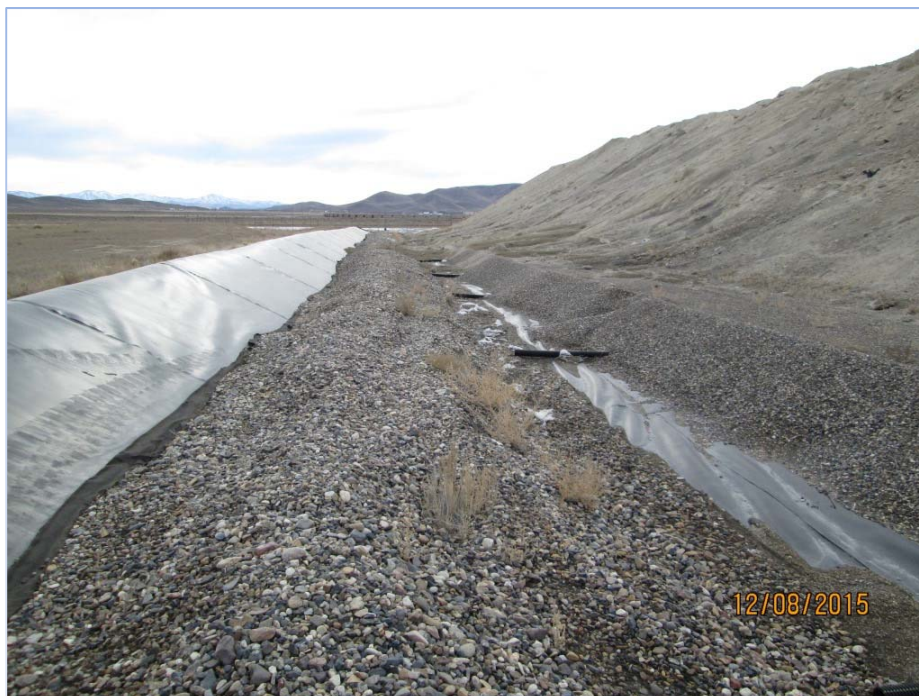
**Photograph 0030:** Cell 1 collection channel on east side (looking south).

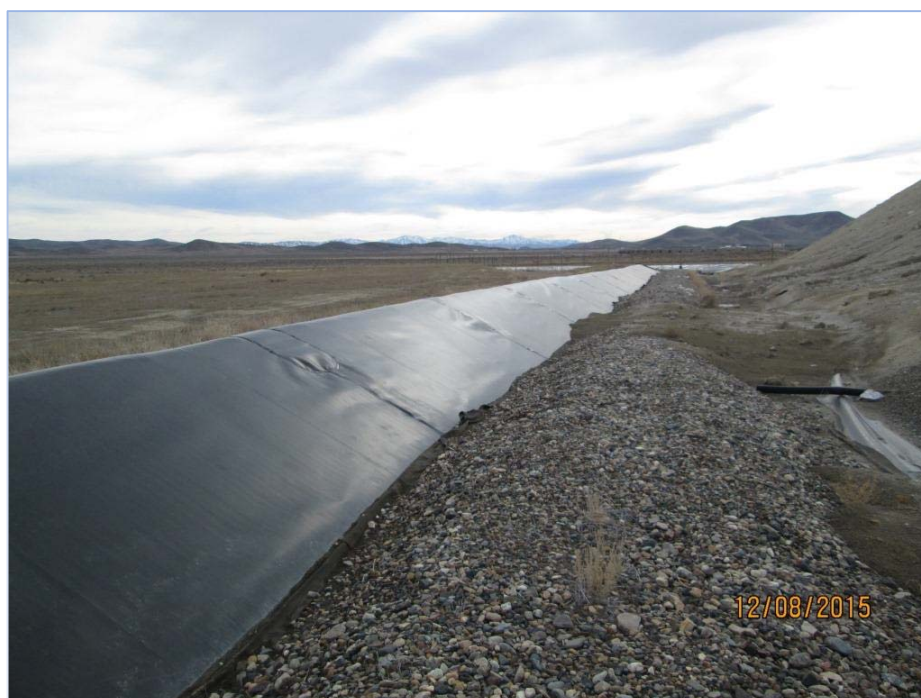
**Photograph 0032:** Cell 1 collection channel on east side (looking south).

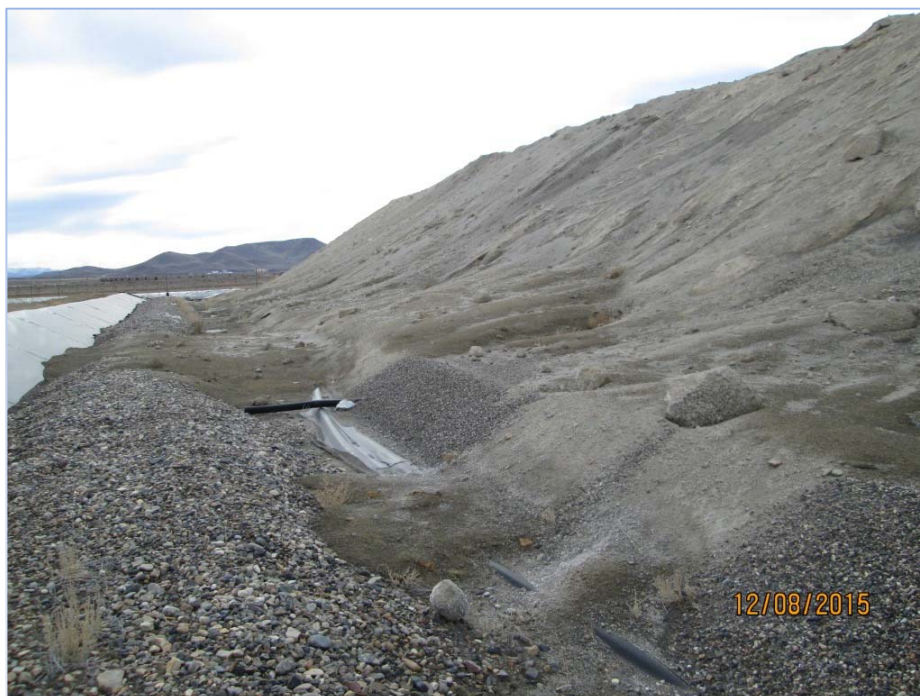
1.6 Other Unusual Conditions		X		
1.7 Evidence of Repairs		X		
<b>2.0 Landfill Materials</b>				
2.1 Lateral Movement	X	X	30, 33, 34, 39, 43	Some minor sloughing noted in CCR.

**Photograph 0033:** Localized slough on east side of Cell 1 (collection channel area).

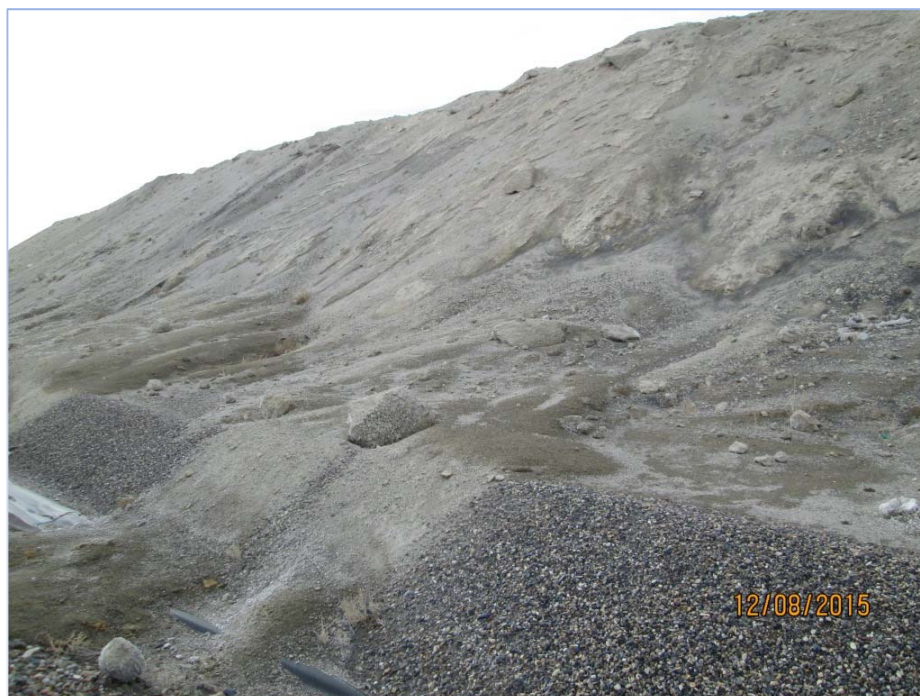
**Photograph 0034:** Localized sloughing of ash fill on east side of Cell 1.

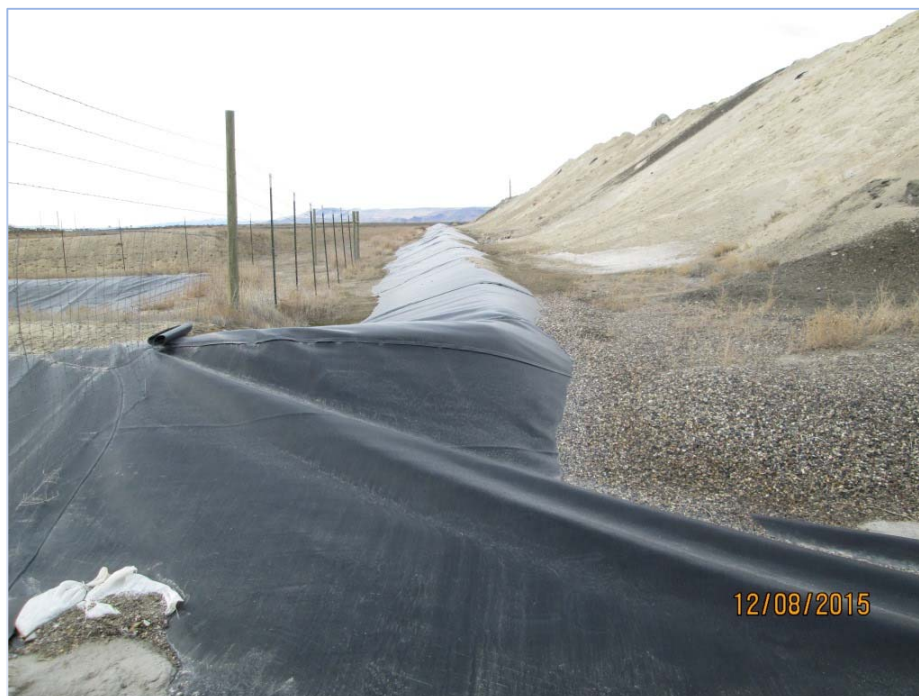
**Photograph 0035:** South side of Cell 1 at outlet to pond (looking west).

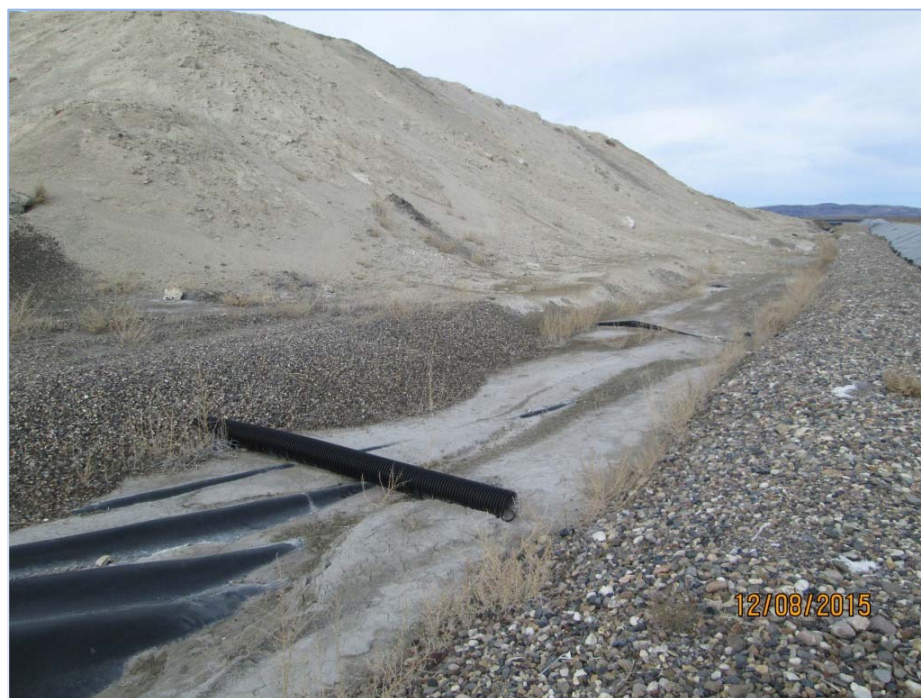
**Photograph 0037:** Southeast corner of Cell 1 (looking north).

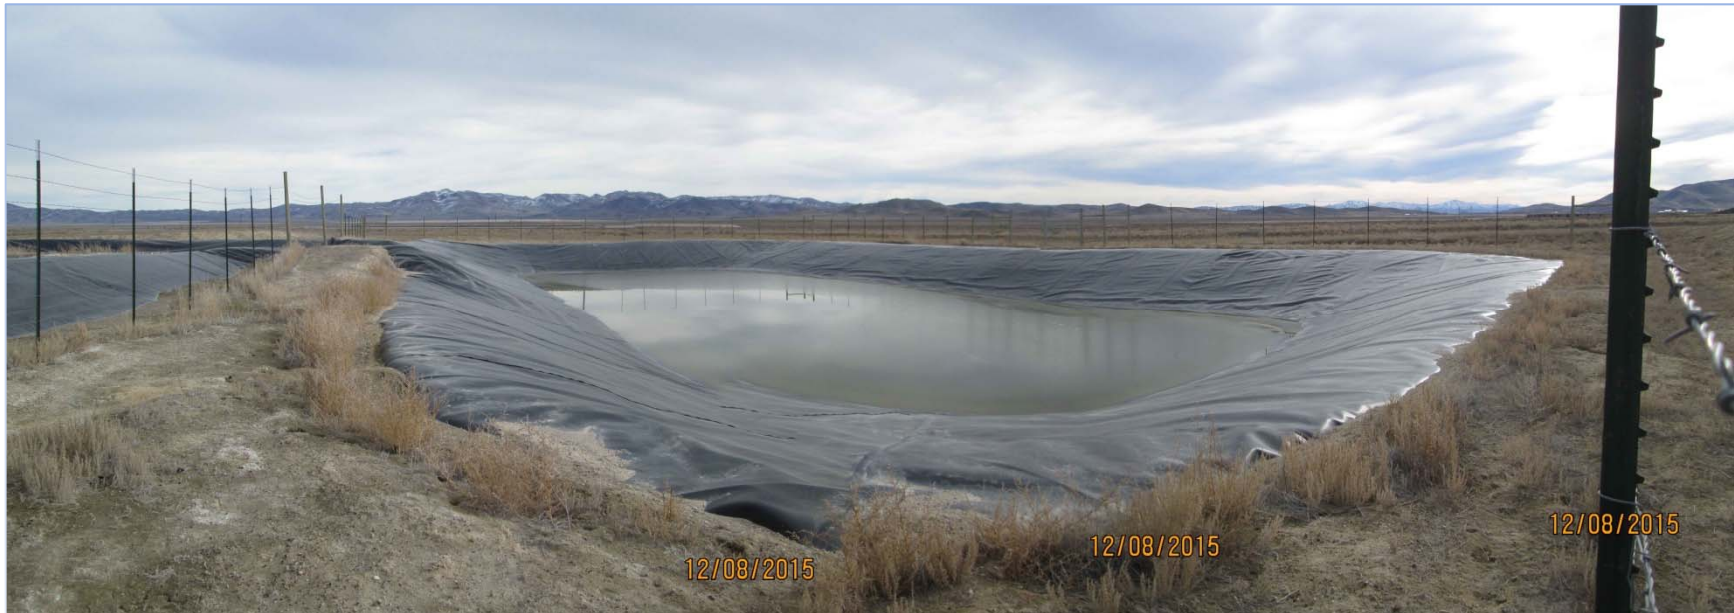
2.7 Miscellaneous		X		
<b>3.0 General</b>				
3.1 Solution Pond(s)	X		Pano 40-42, Pano 61-65	External Stormwater/Leachate Collection Pond. Composite lined with 80-mil HDPE over GCL.

**Panoramic Photographs 0040-0042:** Collection Pond 1.

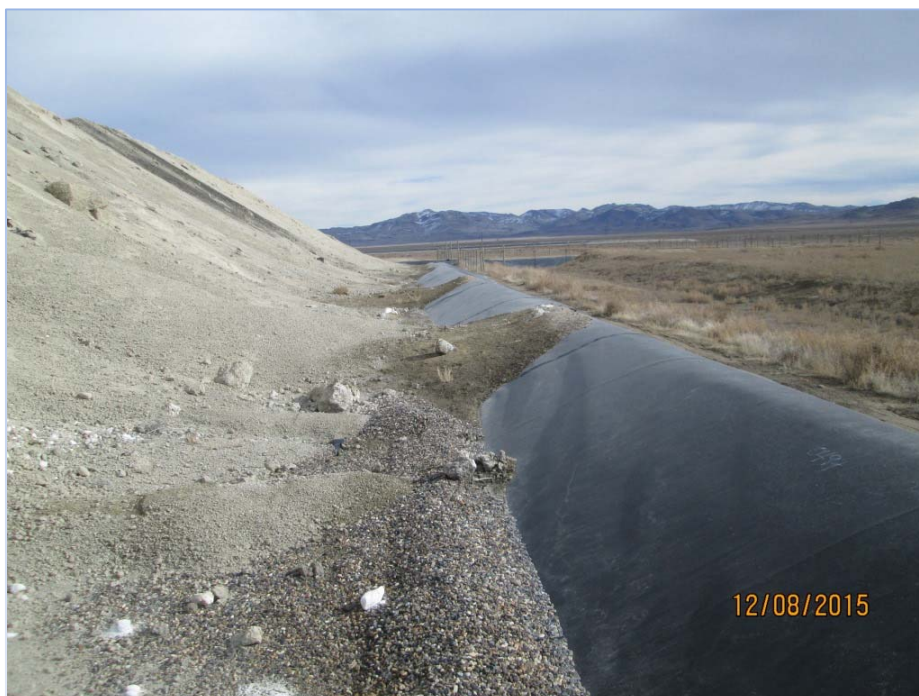
**Photograph 0043:** South side of Cell 1.

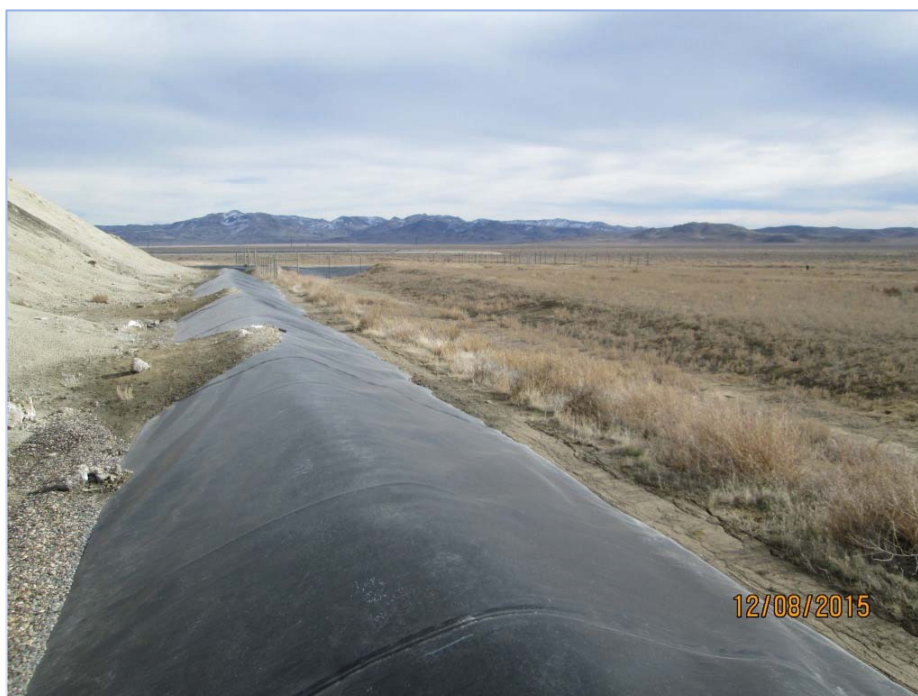
**Photograph 0044:** Downgradient edge of Cell 1. Stormwater diversion channel is on the right.

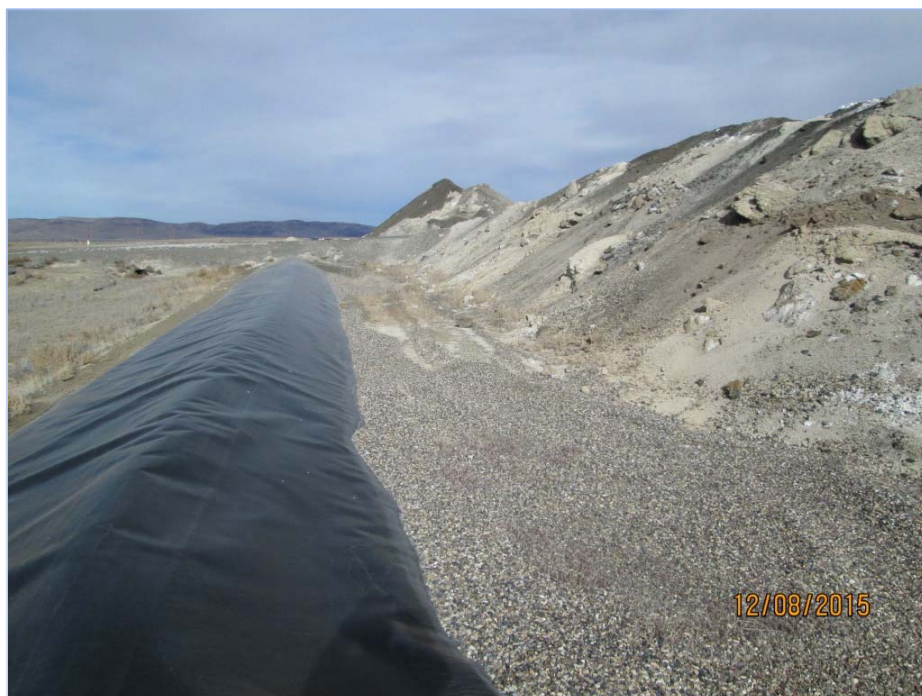
**Photograph 0047:** Southwest corner of Cell 1 (looking north to access ramp).

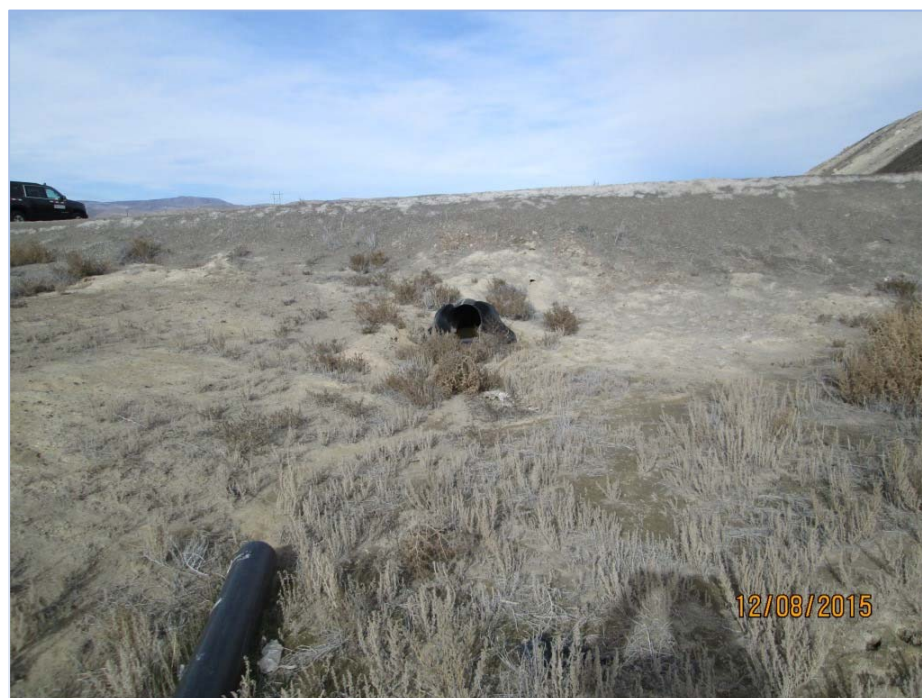
**Photograph 0050:** Drainage culvert beneath access ramp to Cell 1 (upstream end).

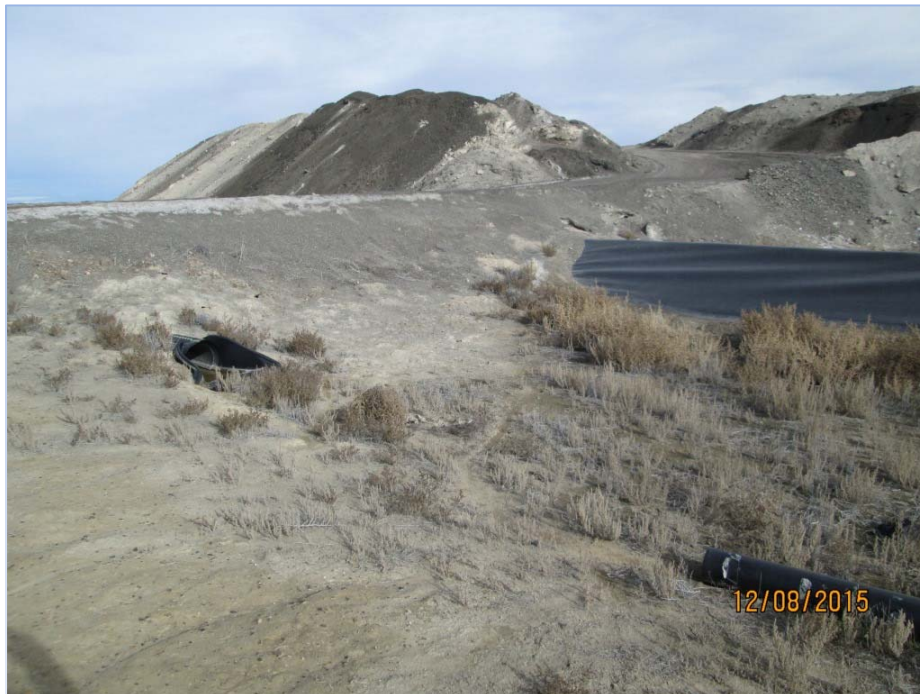
**Photograph 0051:** Drainage culvert beneath access ramp to Cell 1 (downstream end).

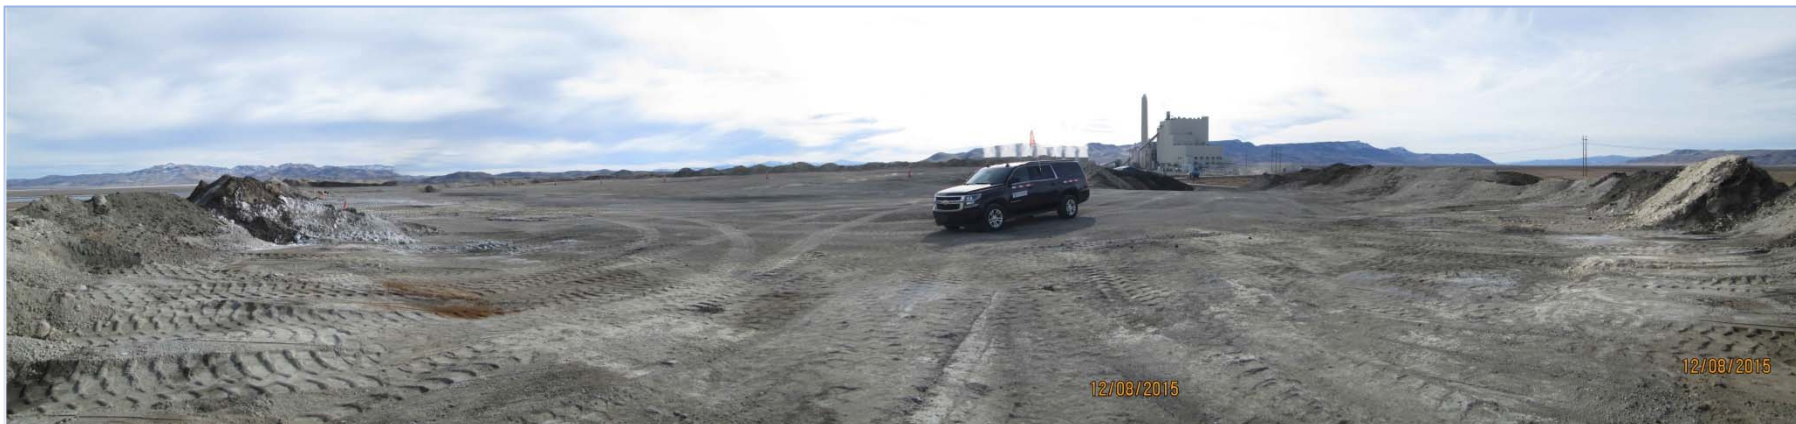
**Panoramic Photographs 0053-0057:** Top of ash fill in Cell 1.

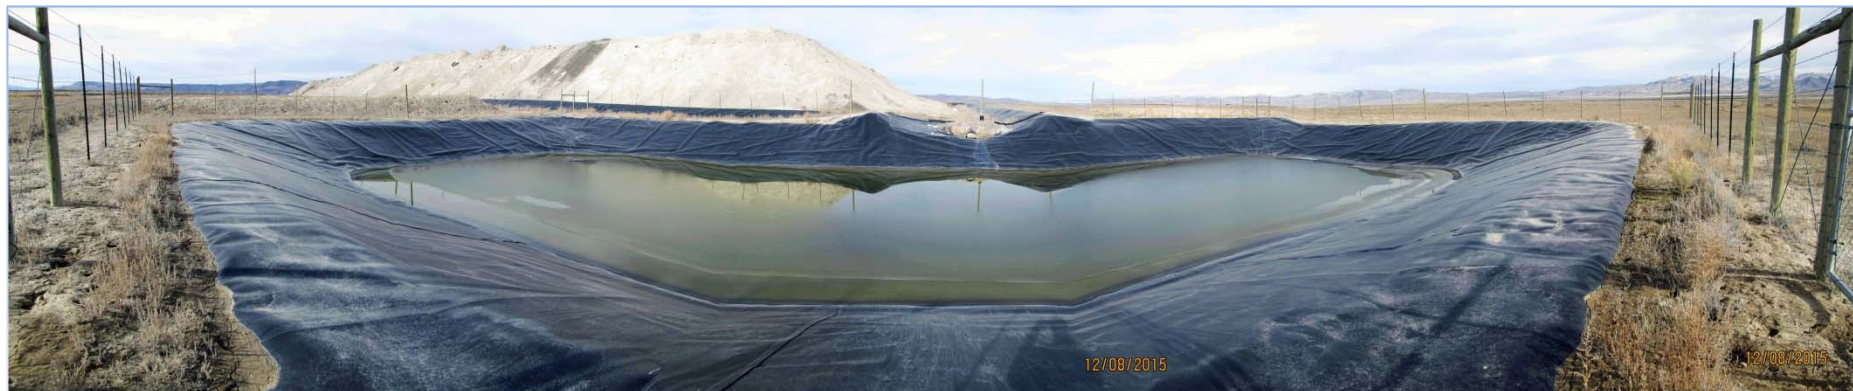
As shown in Photograph 61-65 (panorama), the collection pond (Pond 1) had minor residual water in the base of the pond. No leachate flow from the landfill to the pond was observed at the time of the inspection. The HDPE geomembrane was in good condition and no damage or defects were noted.

**Panoramic Photographs 0061-0065:** Collection Pond 1 at southeast corner of Cell 1.

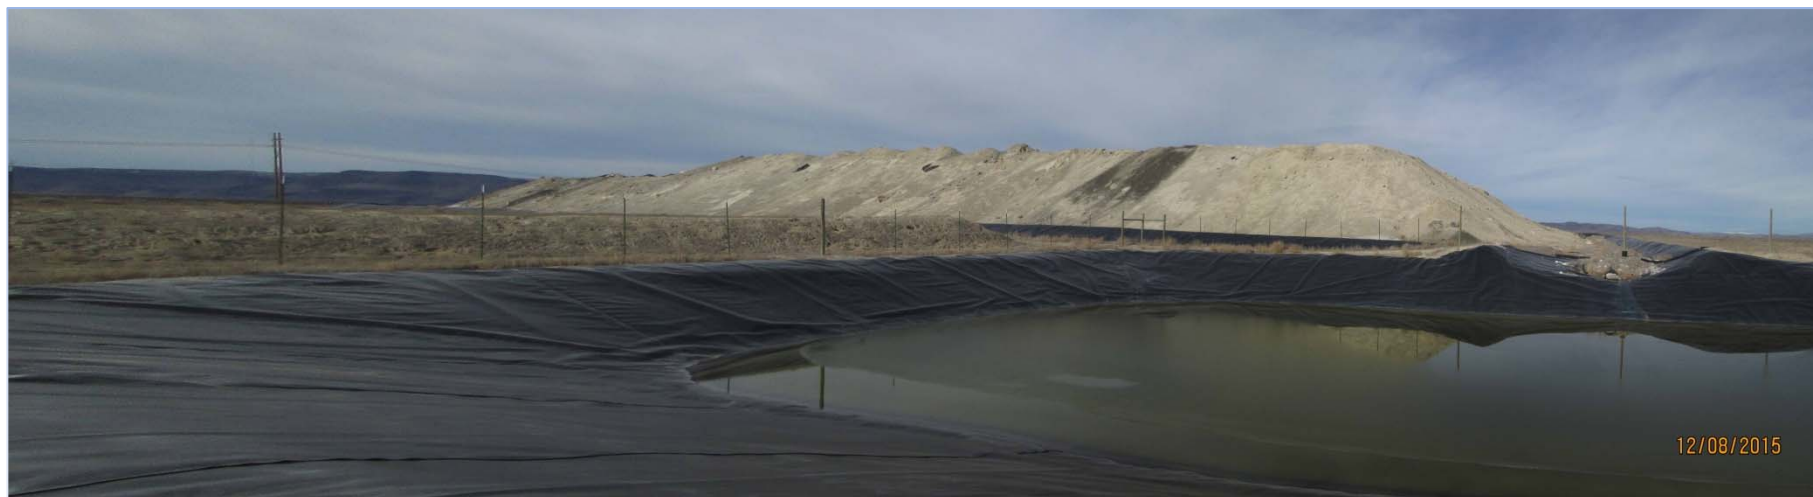
**Panoramic Photographs 0067-0068:** Typical south side of Cell 1. Collection Pond in foreground.

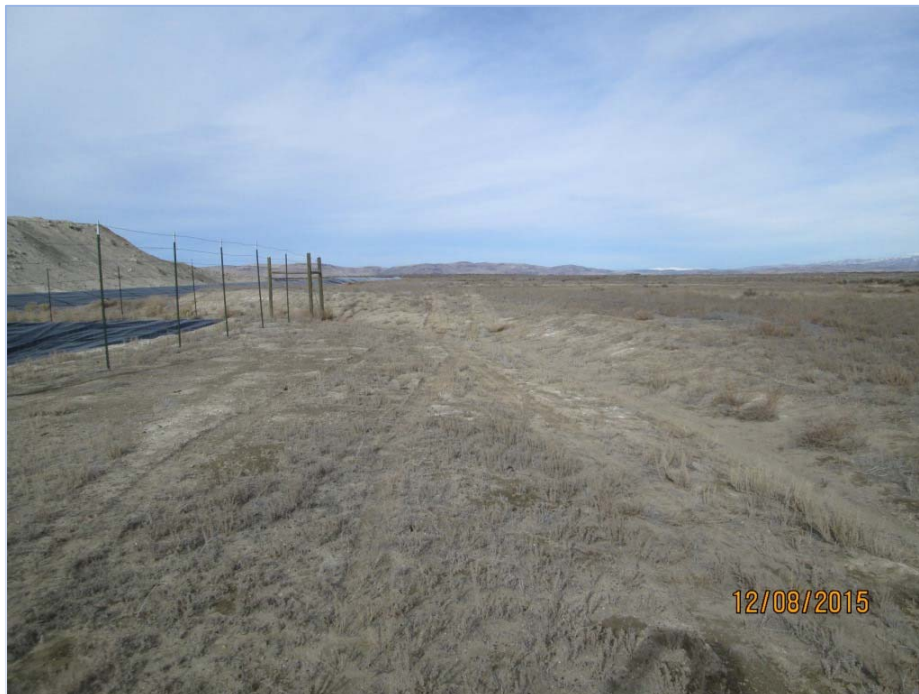
**Photograph 0072:** Stormwater diversion channel on east side of Pond 1.
