NOVEMBER 2016 INSPECTION CCR LANDFILL TS POWER PLANT

**Newmont Nevada Energy Investment, LLC
914 Dunphy Ranch Road
Battle Mountain, Nevada 89820**

**NewFields Mining Design & Technical Services
1301 N. McCarran Blvd., Suite 101
Sparks, Nevada 89431**

**NewFields Project 475.0221
January 2016**

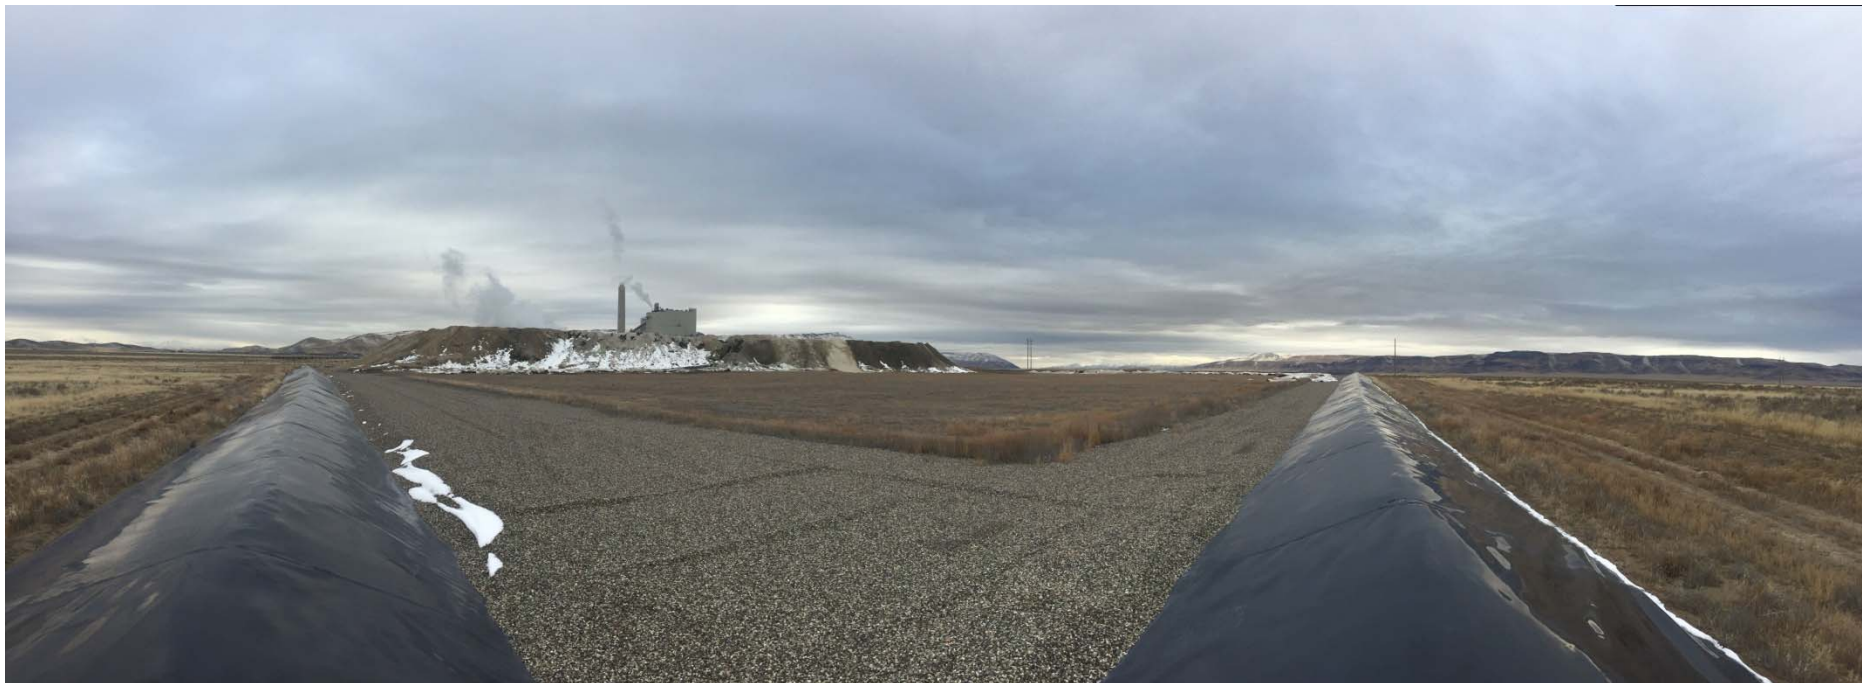
The entire perimeter of the facility was toured as part of the inspection and appeared to be in good to excellent condition. Photographs 1, 2, 3, and 4 are illustrative of typical conditions along the facility perimeter. The perimeter containment berms were observed to be well constructed and the HDPE liner is exposed and appears to be in excellent condition. No signs of damage to the lining system were noted during the inspection. General housekeeping practices around and within the facility were good and the facility appeared to be well maintained.

Photo 1: Panoramic from northeast corner, looking southwest

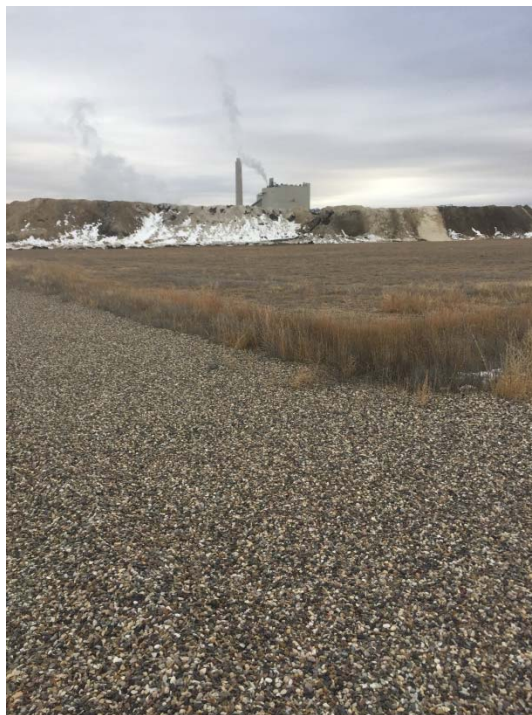
1.2 Evidence of Movement		X	See 1.1	
1.3 Evidence of Sloughing		X	See 1.1	Not in the constructed perimeter berms.
1.4 Evidence of Cracking		X	See 1.1	
1.5 Vegetation	X	X	2	Minor vegetation on the liner cover material

Photograph 2: Cover Material over geomembrane

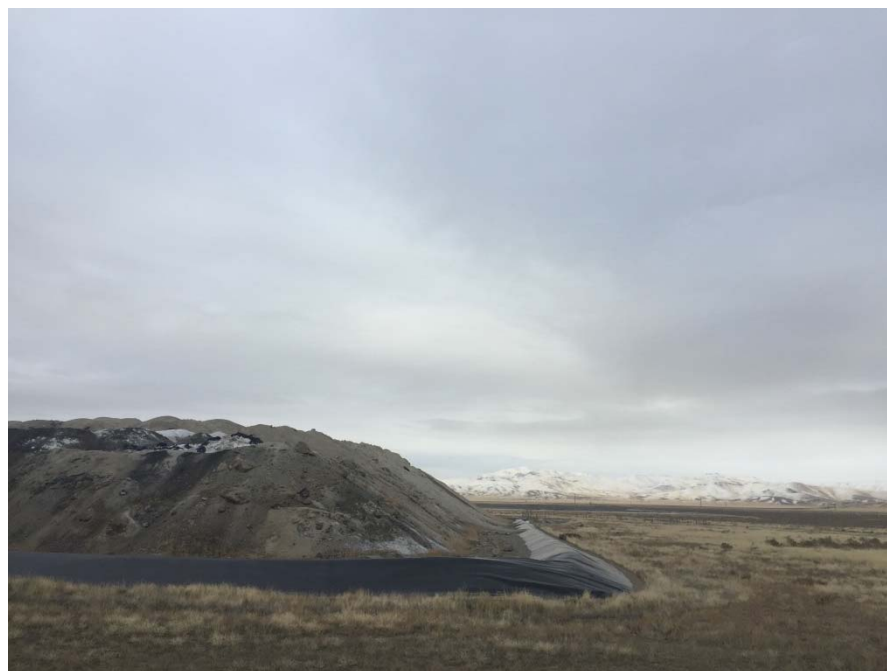
The materials placed within the landfill are predominantly contained within Cell 1 to an approximate height of 20 feet. Placement of material is proceeding to the north into Cell 2. Materials have been placed with approximate angle of repose slopes, minor sloughing on exterior slopes observed during 2015 inspection was not observed during 2016 inspection. Photograph 3 shows typical conditions of the materials contained within the landfill.

Photograph 3: East side of Cell 1 (looking north)

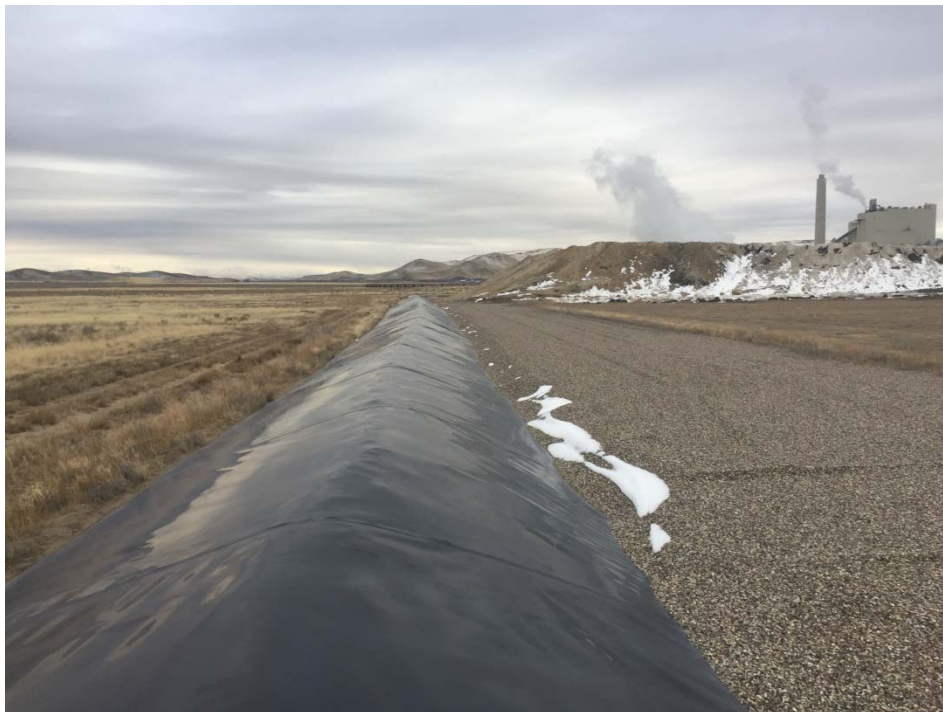
OBSERVED FEATURES	YES	NO	PHOTO NOS.	COMMENTS / NOTES
1.0 Facility Perimeter				
1.1 Evidence of Erosion		X	3, 4, 5,	No erosion along the perimeter of the landfill berms was noted.

Photograph 04: East side of Cell 2 near northeast corner (looking south).

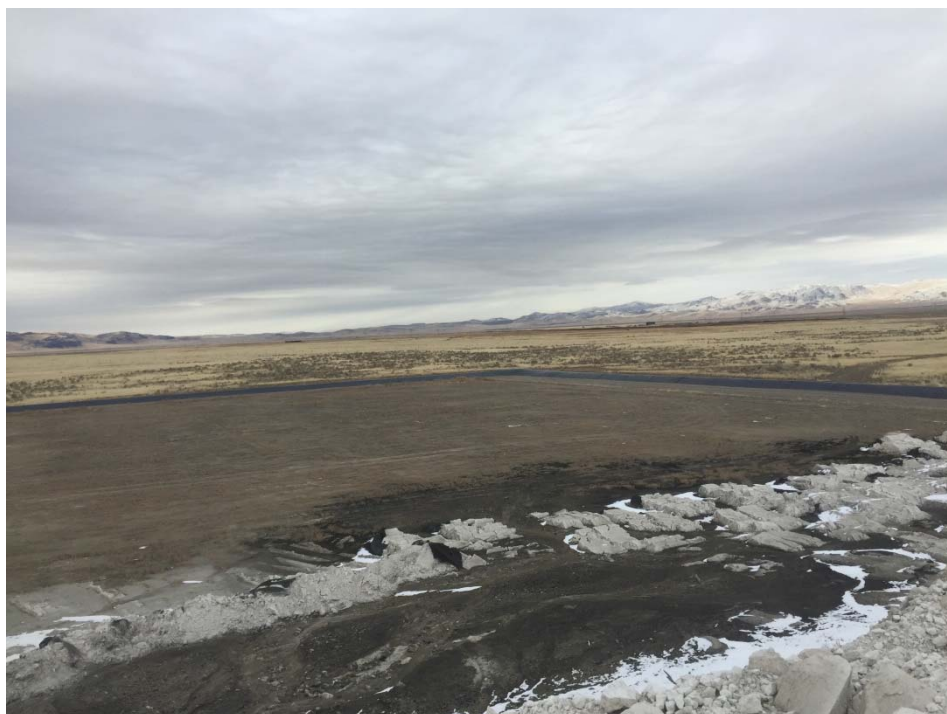
Photograph 5: Cell 2

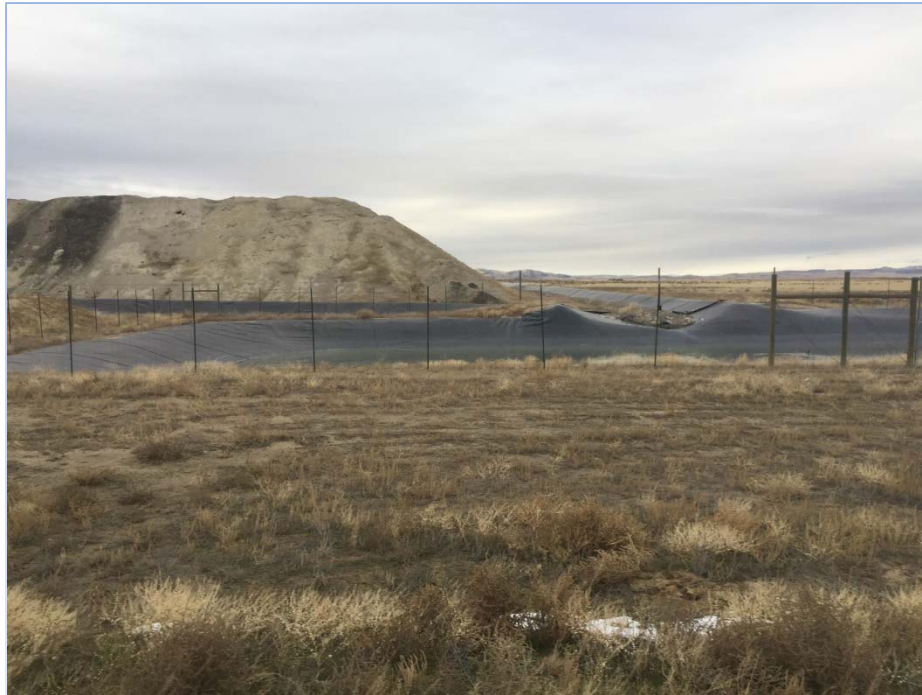
The collection pond had minor accumulated water in the base of the pond. No leachate flow from the landfill to the pond was observed at the time of the inspection. The HDPE geomembrane was in good condition and no damage or defects were noted.

2.4 Erosion		X	See 2.1	Localized.
2.5 Other Unusual Conditions		X		
2.6 Evidence of Repairs		X		
2.7 Miscellaneous		X		
3.0 General				
3.1 Solution Pond(s)	X		6	External Stormwater/Leachate Collection Pond. Composite lined with 80-mil HDPE over GCL.

Photograph 6: Collection Pond

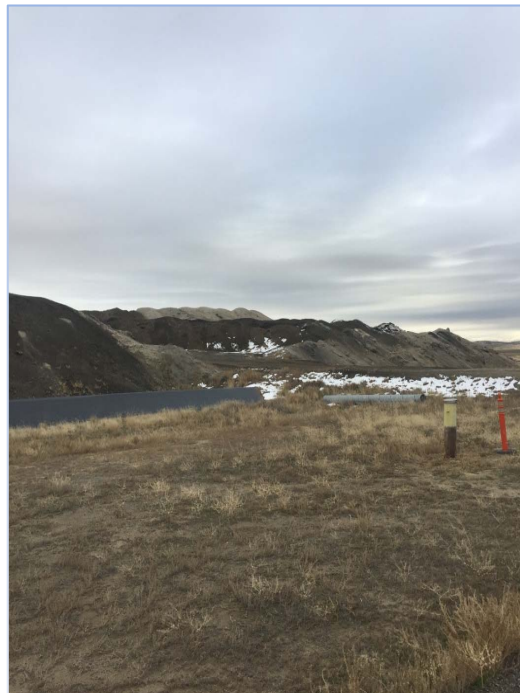
Stormwater is routed around the perimeter of the facility by diversion channels and/or the perimeter berms that surround the landfill. An access ramp over the perimeter berm is located near the southwest corner of Cell 1. Stormwater controls were observed to be consistent with the intent of the design and no issues were noted as part of the inspection.

3.2 Embedded/buried structures		X		
3.3 Accessible by Truck	X		7	Landfill access ramp
3.4 Public Access		X		Area fenced.
3.5 Other Unusual Conditions		X

Photograph 7: Access Ramp
