**DECEMBER 2017 INSPECTION
CCR LANDFILL
TS POWER PLANT**

Newmont Nevada Energy Investment, LLC
914 Dunphy Ranch Road
Battle Mountain, Nevada 89820

NewFields Project 475.0221.003
January 2018

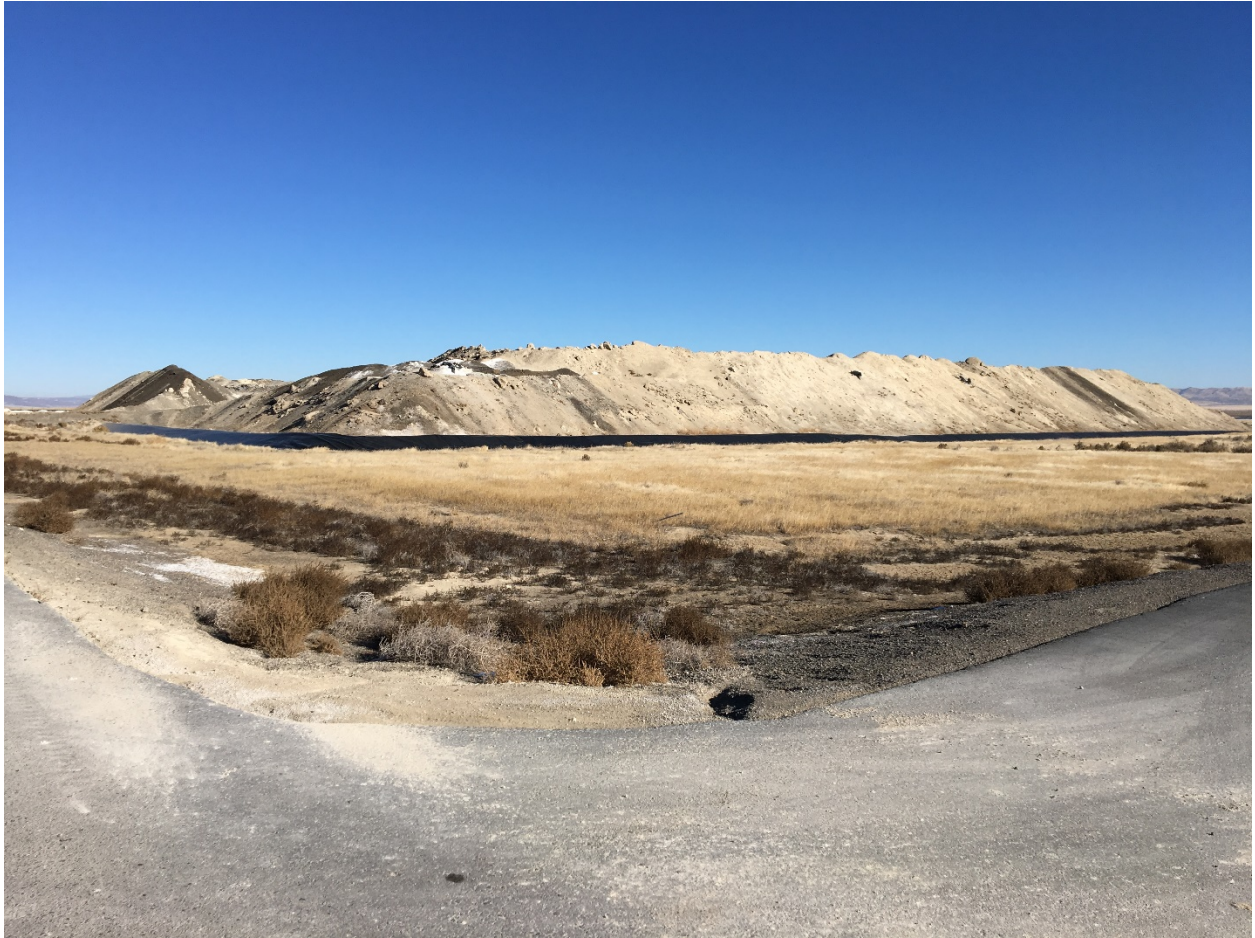
Photo 1. Southwest Corner of CCR, Cell 1 - View Northeast

OBSERVED FEATURES	YES	NO	PHOTO NOS.	COMMENTS / NOTES
1.0 Facility Perimeter				
1.1 Evidence of Erosion		X	1, 3, 4, 5, 6, 7, 8, 9, 10, 16, and 18	No erosion along the perimeter of the landfill berms was noted.

1.6 Other Unusual Conditions		X		
1.7 Evidence of Repairs		X		
2.0 Landfill Materials				
2.1 Lateral Movement	X	X	1, 4, 12, 13, 14, 16, and 17	Some minor sloughing noted in CCR.

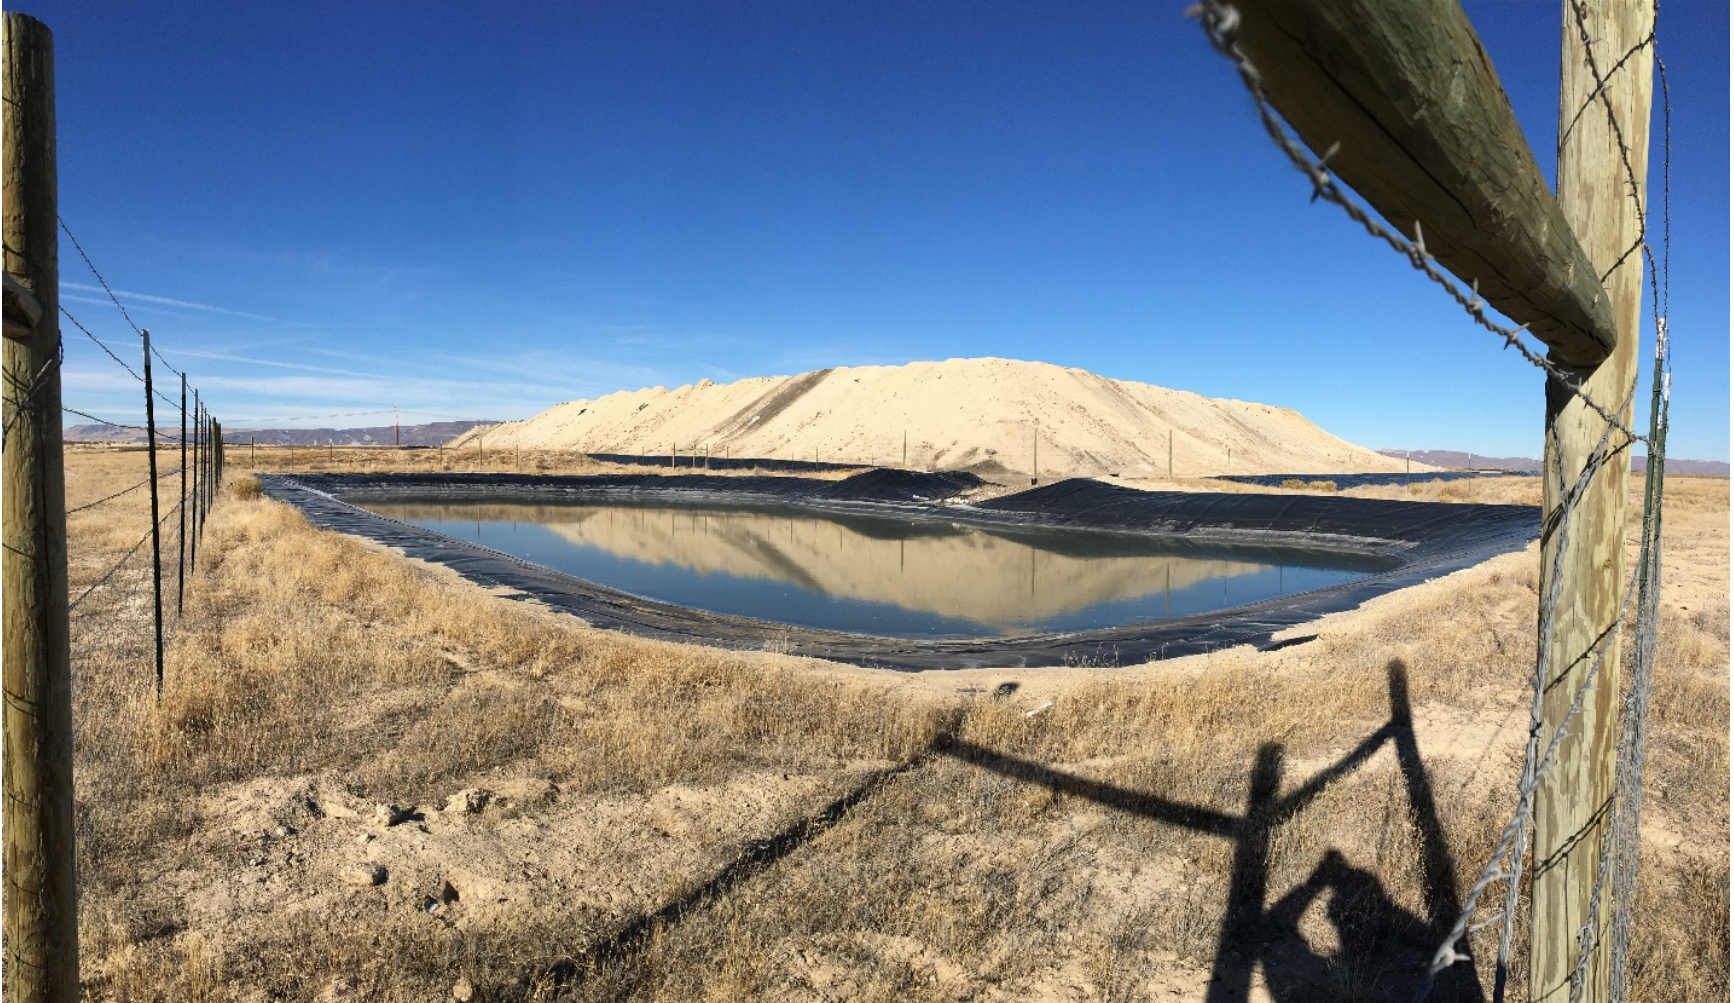
Photo 2. Collection Pond 1 - View Northwest

As shown in Photograph 2, the collection pond had a water level approximately 2 feet below the inlet spillway. No leachate flow from the landfill to the pond was observed at the time of the inspection. The HDPE geomembrane was in good condition and no damage or defects were noted.

2.7 Miscellaneous		X		
3.0 General				
3.1 Solution Pond(s)	X		2 and 15	External Stormwater/Leachate Collection Pond. Composite lined with 80-mil HDPE over GCL.

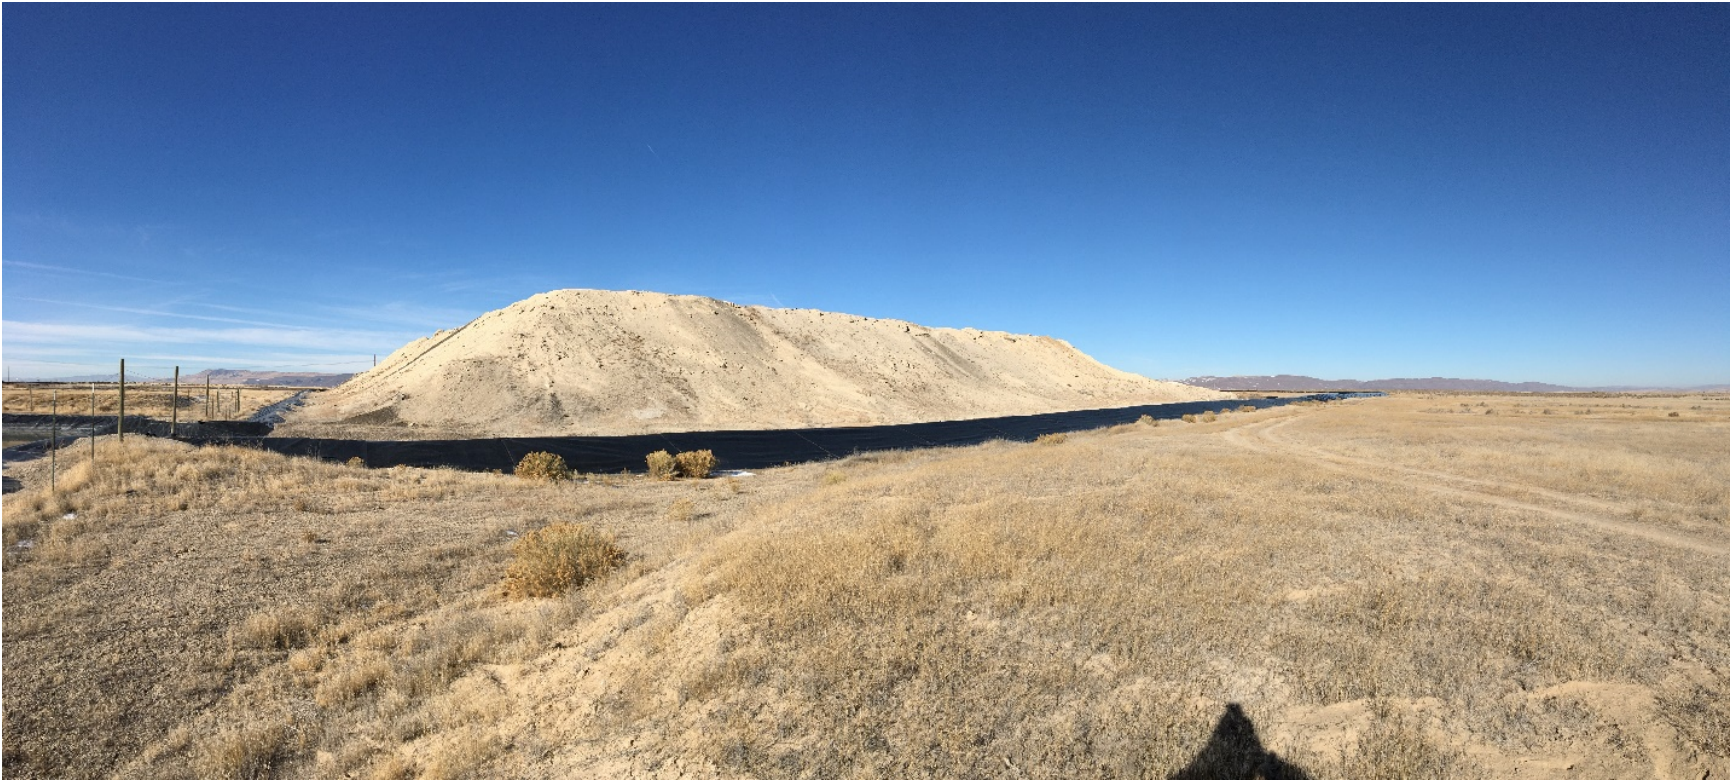
Photo 3. Southeast Corner of CCR, Cell 1 - View Northwest

The entire perimeter of the facility was toured as part of the inspection and appeared to be in good to excellent condition. Photographs 3, 4, 5, 6, 7, 8, 9, 10, 16, and 18 are illustrative of typical conditions along the facility perimeter. The perimeter containment berms were observed to be well constructed and the HDPE liner is exposed and appears to be in excellent condition. No signs of damage to the lining system were noted during the inspection. General housekeeping practices around and within the facility were good and the facility appeared to be well maintained.

Stormwater is routed around the perimeter of the facility by diversion channels and/or the perimeter berms that surround the landfill. Typical diversions are shown in Photographs 3, 4, 5, 6, 7, 8, 9, 10, 11, 16, and 17. An access ramp over the perimeter berm is located near the southwest corner of Cell 1 (Photograph 11).. Stormwater controls were observed to be consistent with the intent of the design and no issues were noted as part of the inspection.

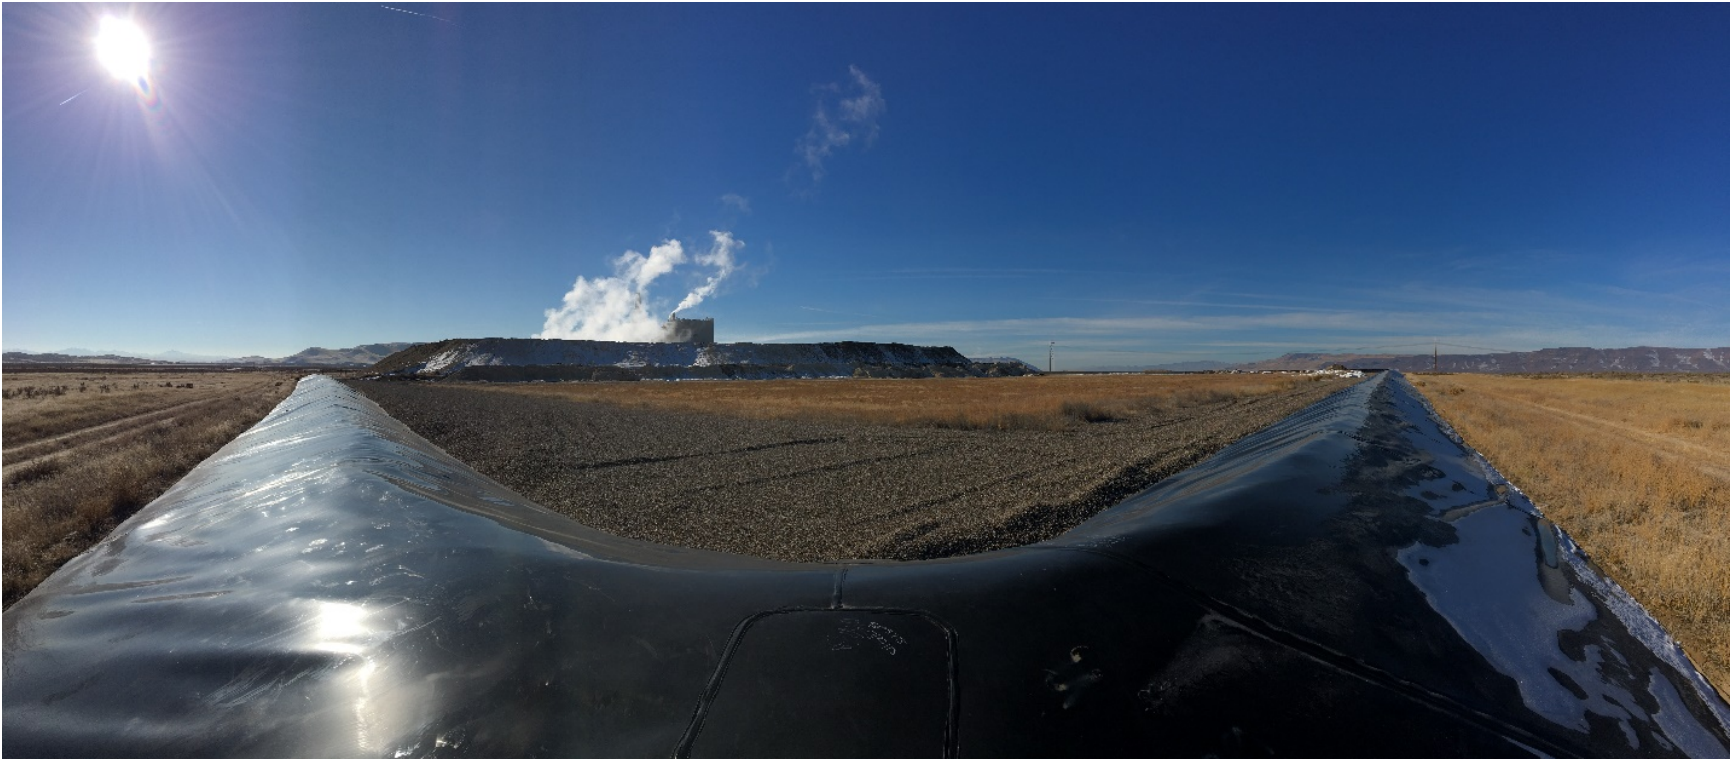
Photo 5. Northeast Corner of CCR, Cell 2 - View Southwest

1.2 Evidence of Movement		X	See 1.1	
1.3 Evidence of Sloughing		X	See 1.1	Not in the constructed perimeter berms.
1.4 Evidence of Cracking		X	See 1.1	
1.5 Vegetation	X	X	5, 6, 7, 8, 9, and 10	Minor vegetation on the liner cover material

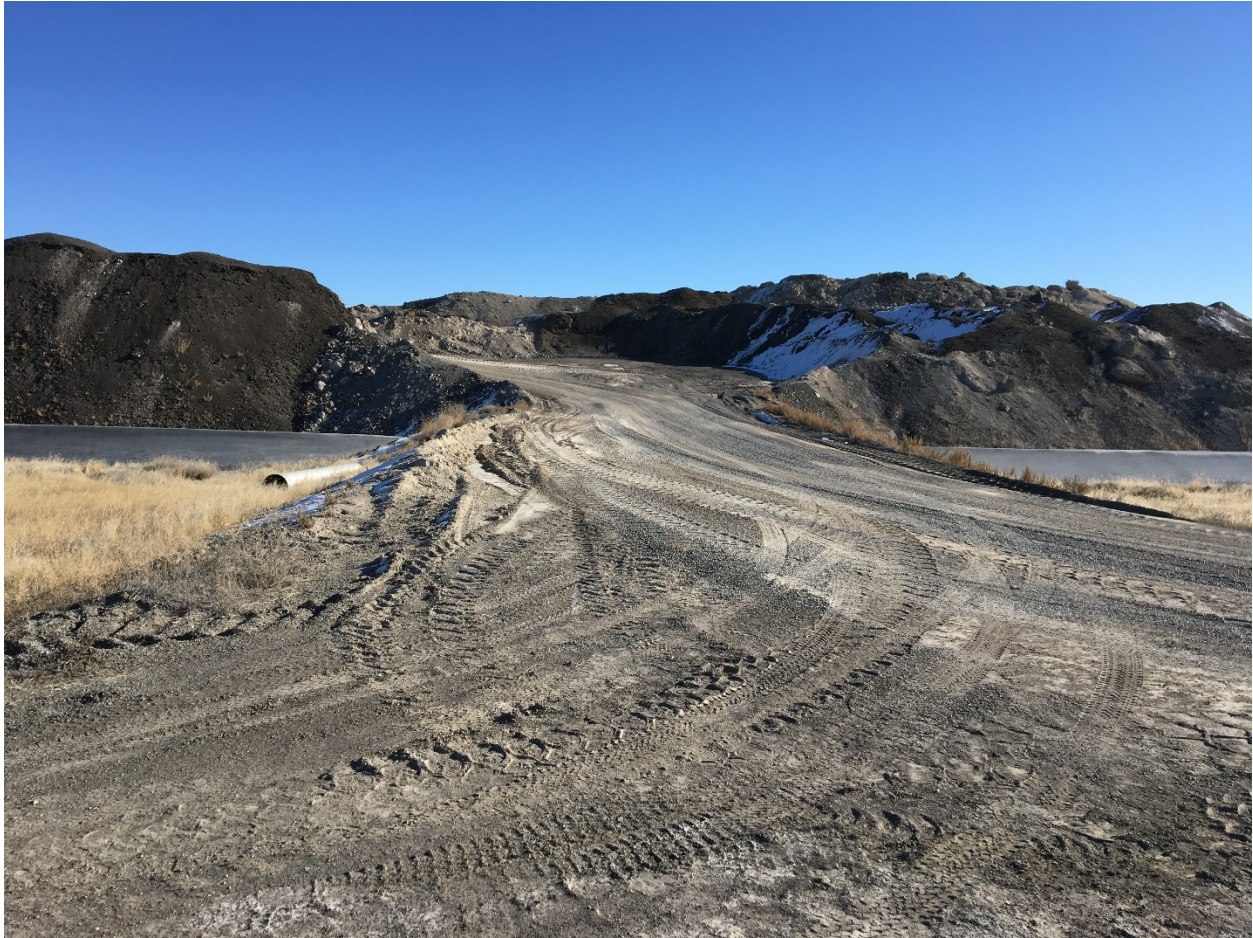
Photo 11. Access to CCR, Cell 1 - View West

3.2 Embedded/buried structures		X		
3.3 Accessible by Truck	X		11	Landfill access ramp
3.4 Public Access		X	2	Area fenced.
3.5 Other Unusual Conditions		X
