TS POWER PLANT CCR LANDFILL – 2018 INSPECTION

Newmont Nevada Energy Investment, LLC
914 Dunphy Ranch Road
Battle Mountain, Nevada 89820

NewFields Mining Design & Technical Services
225 Silver Street, Suite 100
Elko, Nevada 89801

NewFields Project 475.0221.004
December 18, 2018

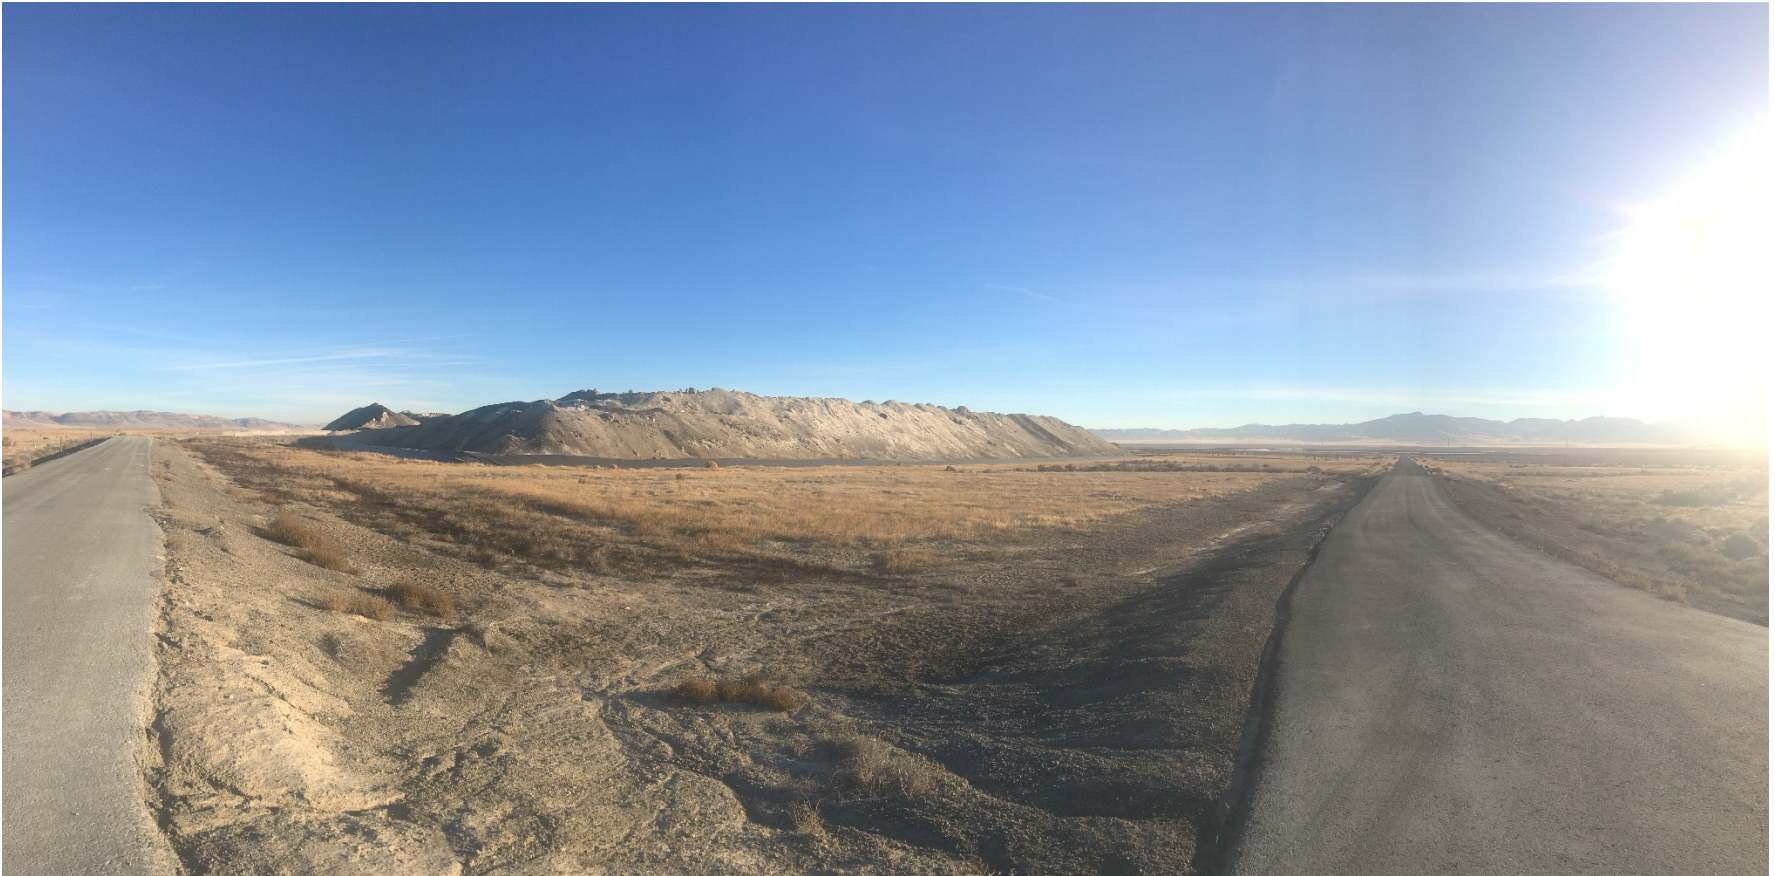
OBSERVED FEATURES	YES	NO	PHOTO NOS.	COMMENTS / NOTES
1.0 Facility Perimeter				
1.1 Evidence of Erosion		X	1,4,5,6,12, and 13	No erosion along the perimeter of the landfill berms was noted.

Photo 1. Southwest Corner of CCR, Cell 1 - View Northeast

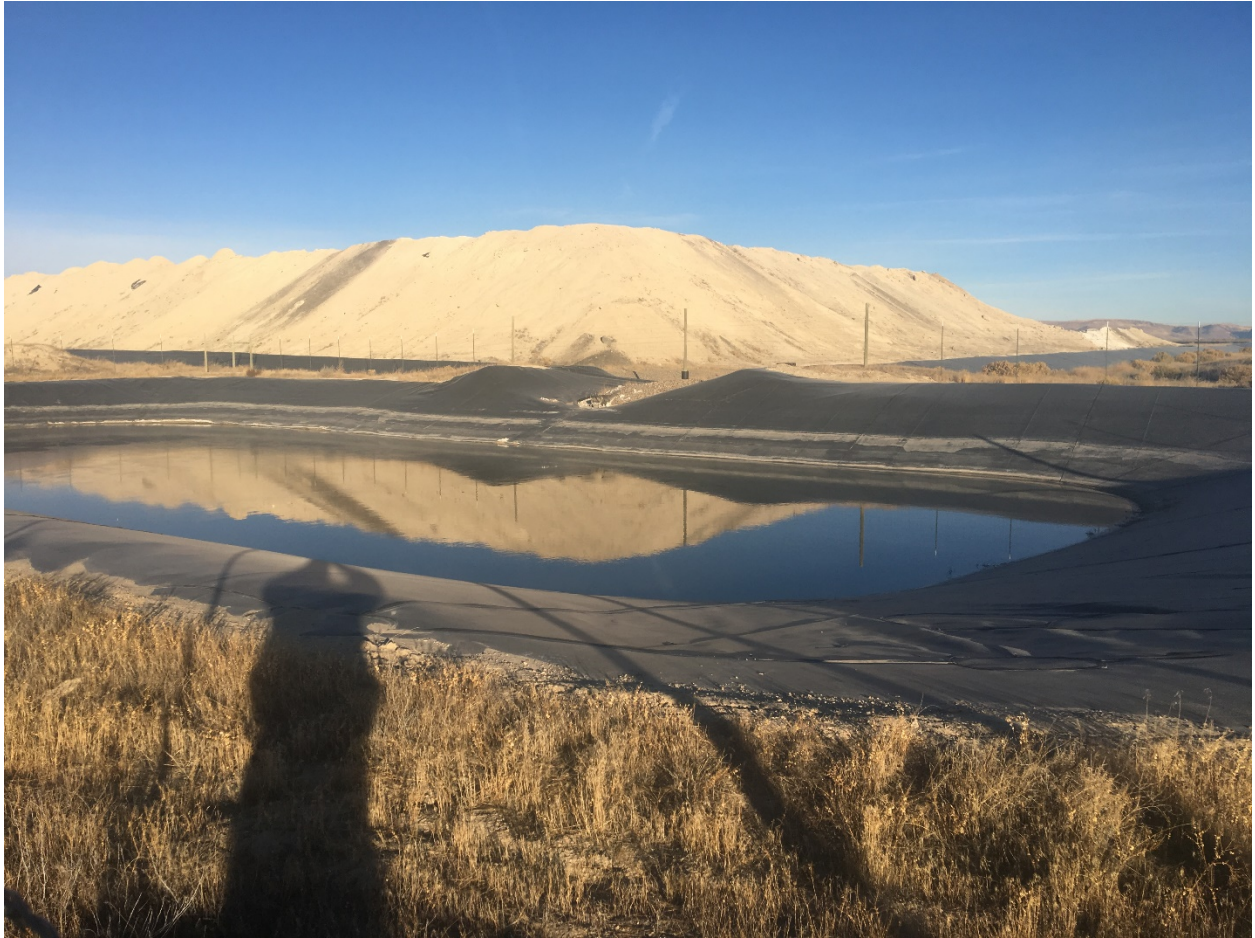
As shown in Photograph 2 and 3, the collection pond had a water level approximately 4 feet below the inlet spillway. No leachate flow from the landfill to the pond was observed at the time of the inspection. The HDPE geomembrane was in good condition and no damage or defects were noted.

2.7 Miscellaneous		X		
3.0 General				
3.1 Solution Pond(s)	X		2 and 3	External Stormwater/Leachate Collection Pond. Composite lined with 80-mil HDPE over GCL.

Photo 2. Collection Pond 1 - View Northwest

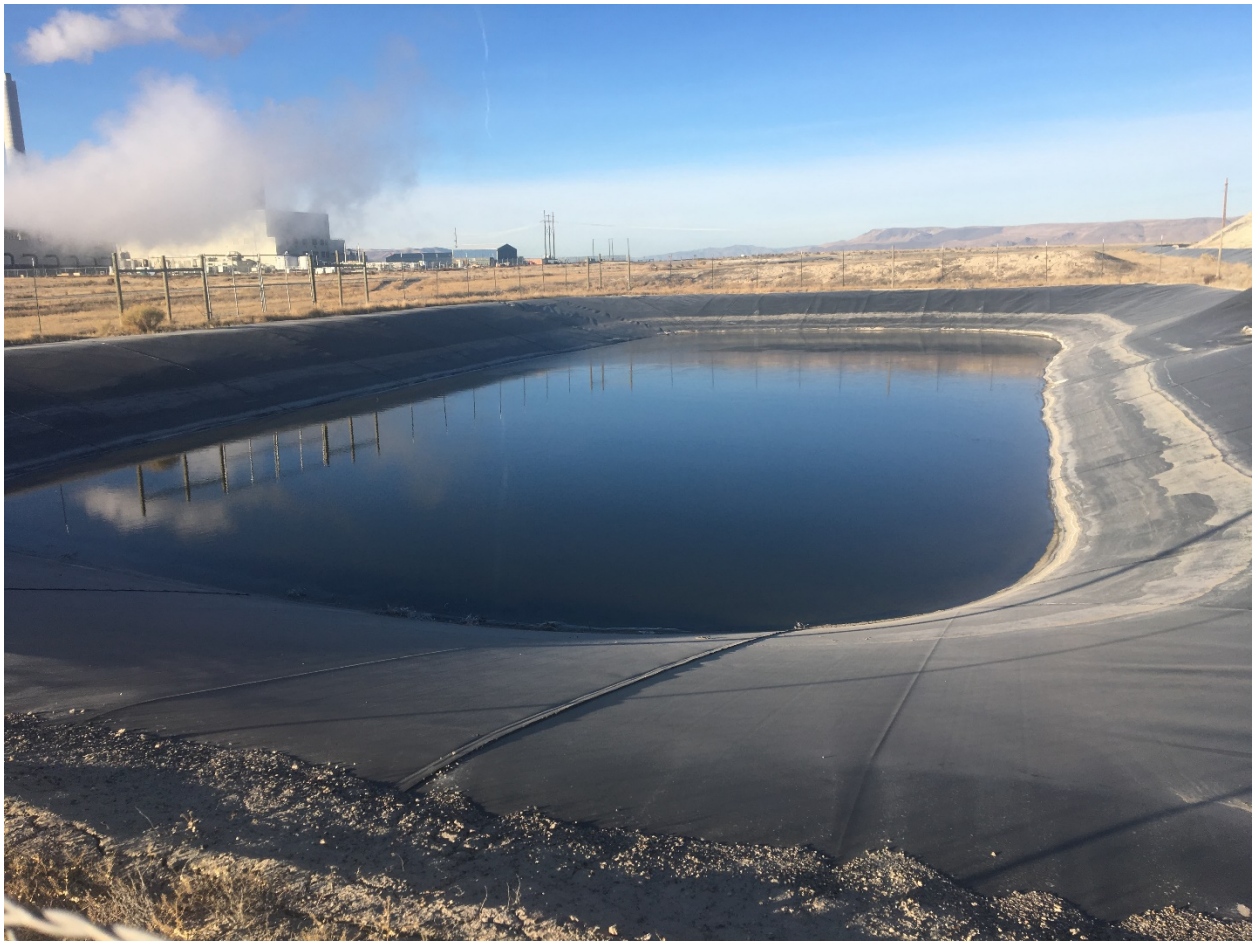
Photo 3. Collection Pond 1 - View West

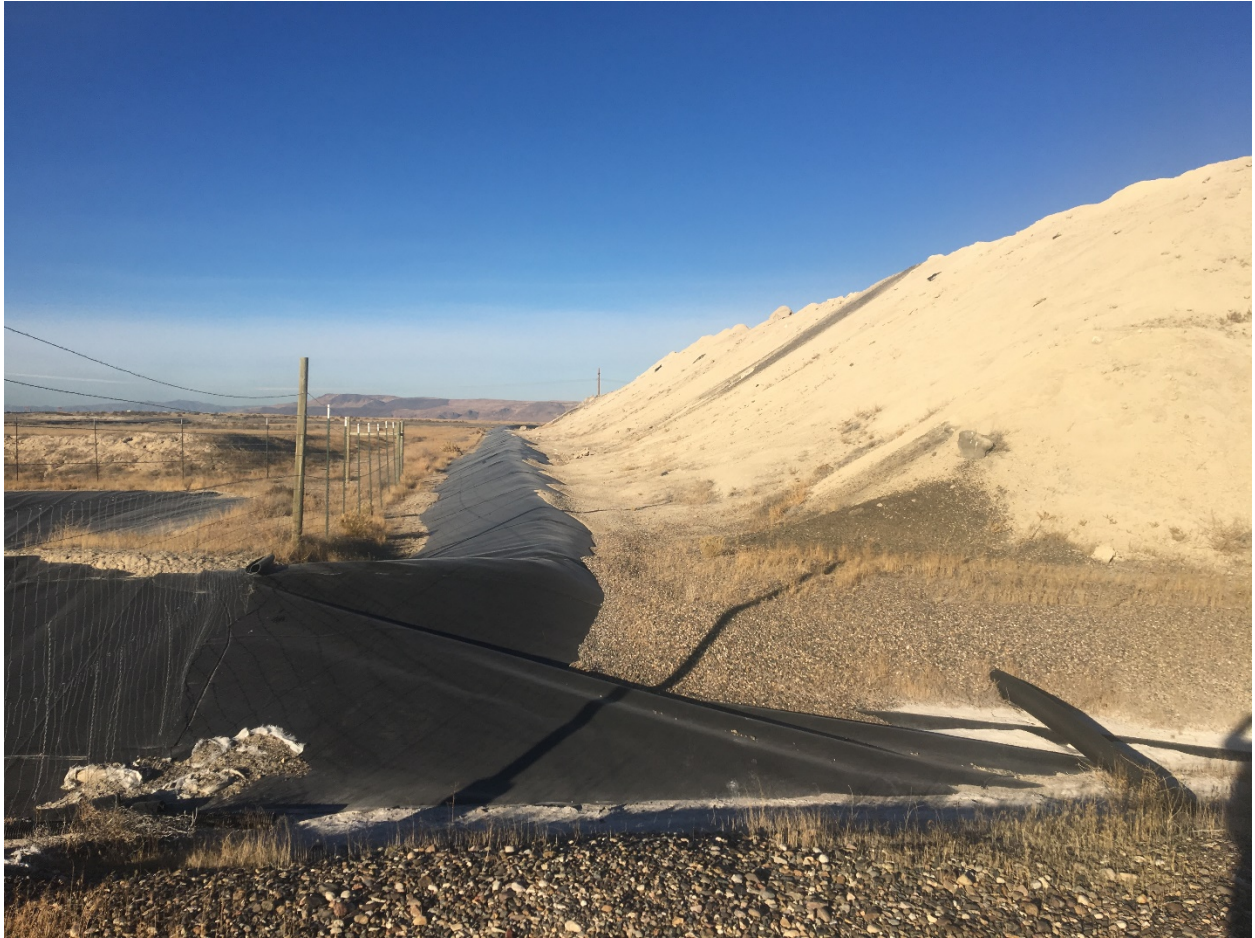
The entire perimeter of the facility was toured as part of the inspection and appeared to be in good to excellent condition. Photographs 4, 5, 6, 7, 8, 9, 10, 11, 12, and 13 are illustrative of typical conditions along the facility perimeter. The perimeter containment berms were observed to be well constructed and the HDPE liner is exposed and appears to be in excellent condition. No signs of damage to the lining system were noted during the inspection. General housekeeping practices around and within the facility were good and the facility appeared to be well maintained.

1.6 Other Unusual Conditions		X		
1.7 Evidence of Repairs		X		
2.0 Landfill Materials				
2.1 Lateral Movement	X	X	4,5,6, and 13	Some minor sloughing noted in 2017 inspection, No change in 2018 inspection.

Photo 4. South Perimeter Berm, Southeast Corner, Cell 1 - View West

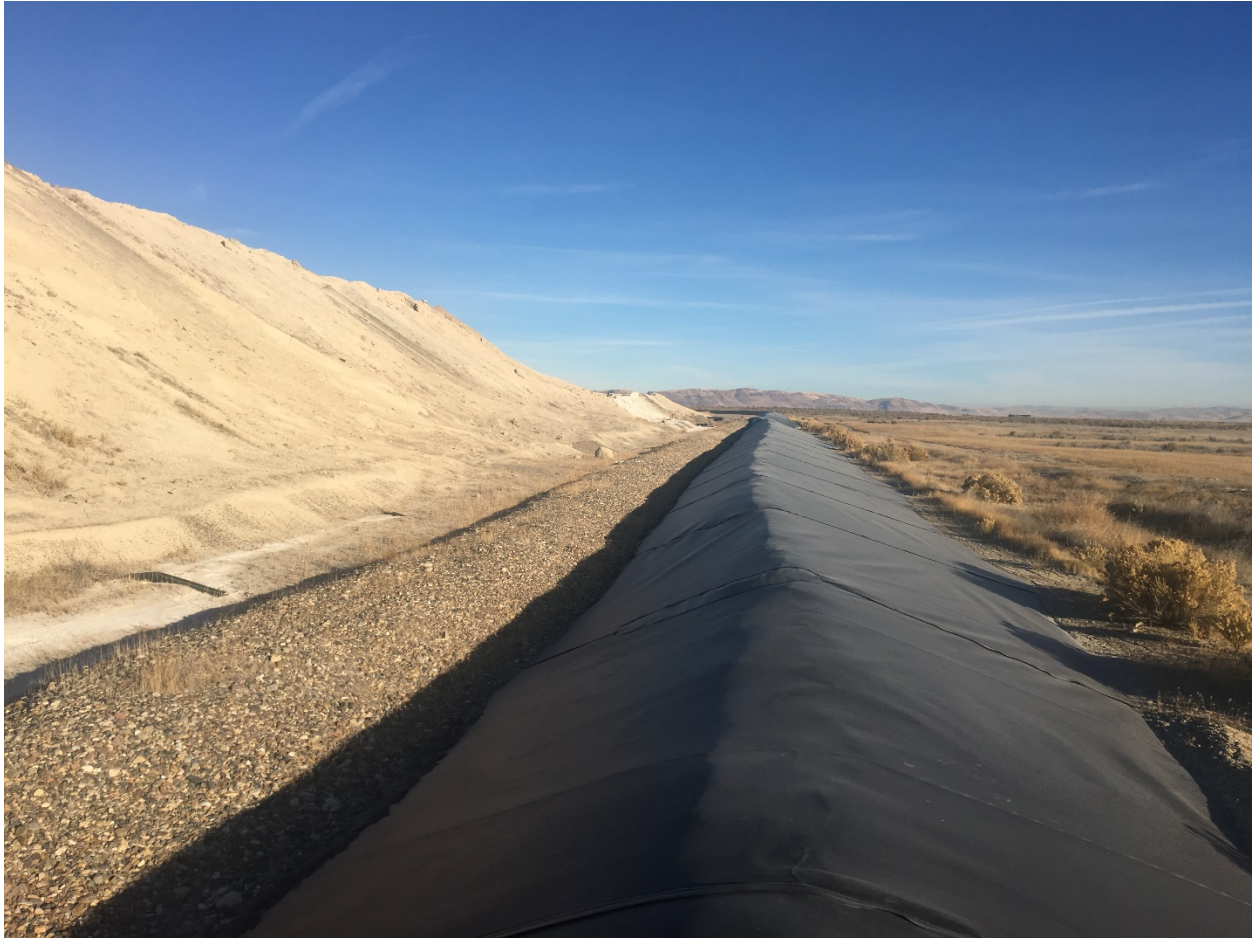
Stormwater is routed around the perimeter of the facility by diversion channels and/or the perimeter berms that surround the landfill. Typical diversions are shown in Photographs 5, 7, 8, 9, 10, 11, 12, and 13. An access ramp over the perimeter berm is located near the southwest corner of Cell 1 (Photograph 12). Stormwater controls were observed to be consistent with the intent of the design and no issues were noted as part of the inspection.

Photo 5. East Perimeter Berm, Southeast Corner, Cell 1 - View North

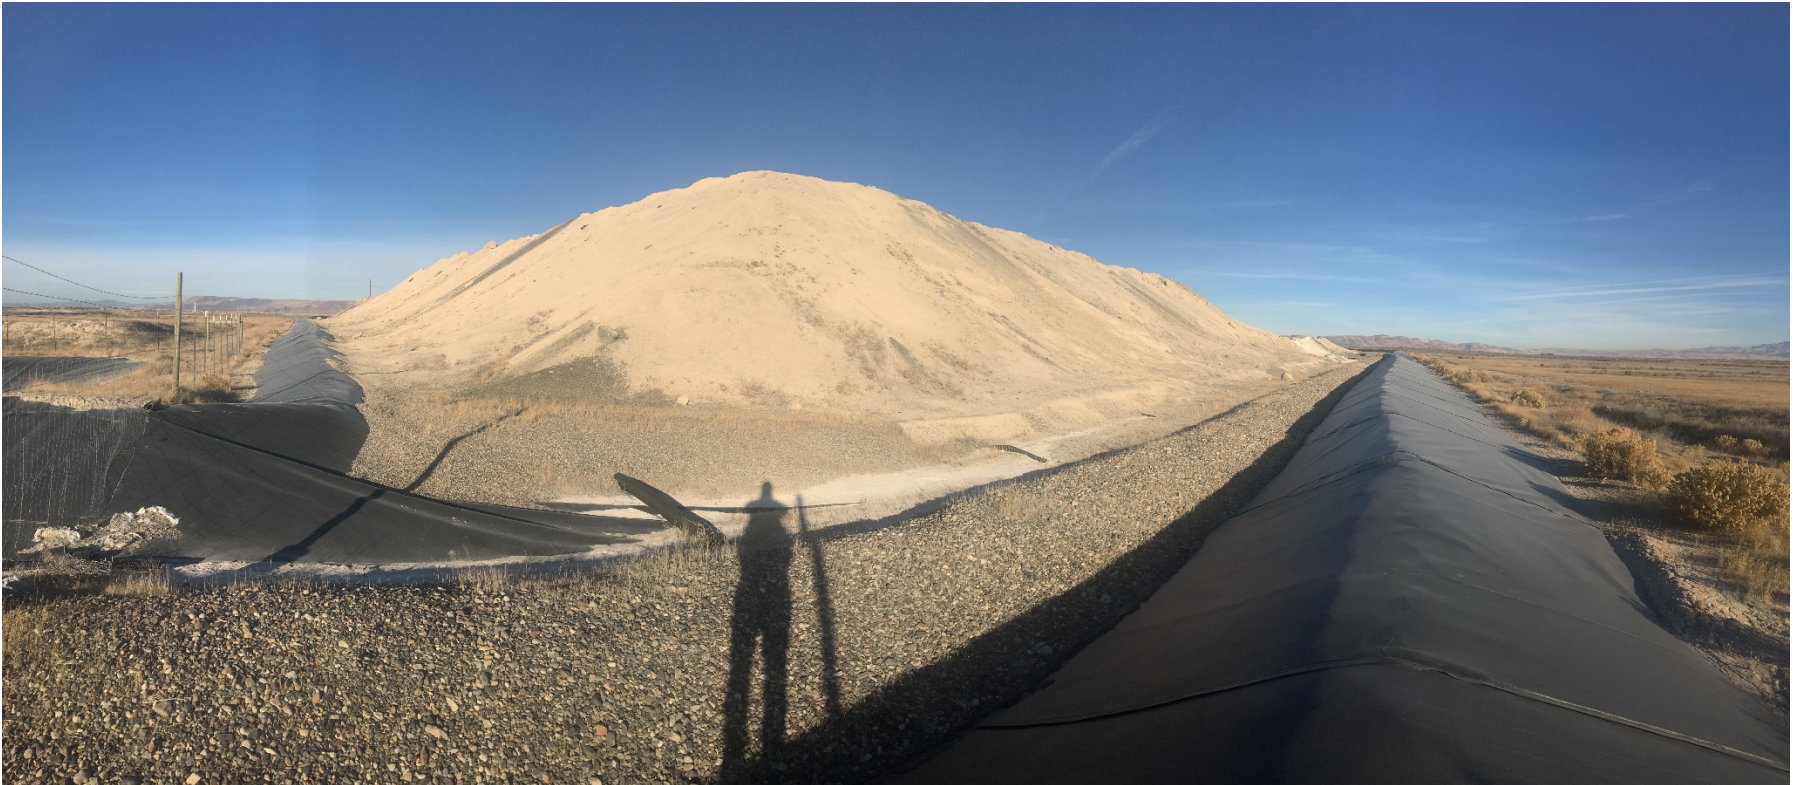
Photo 6. Southeast Corner of CCR, Cell 1 - View Northwest

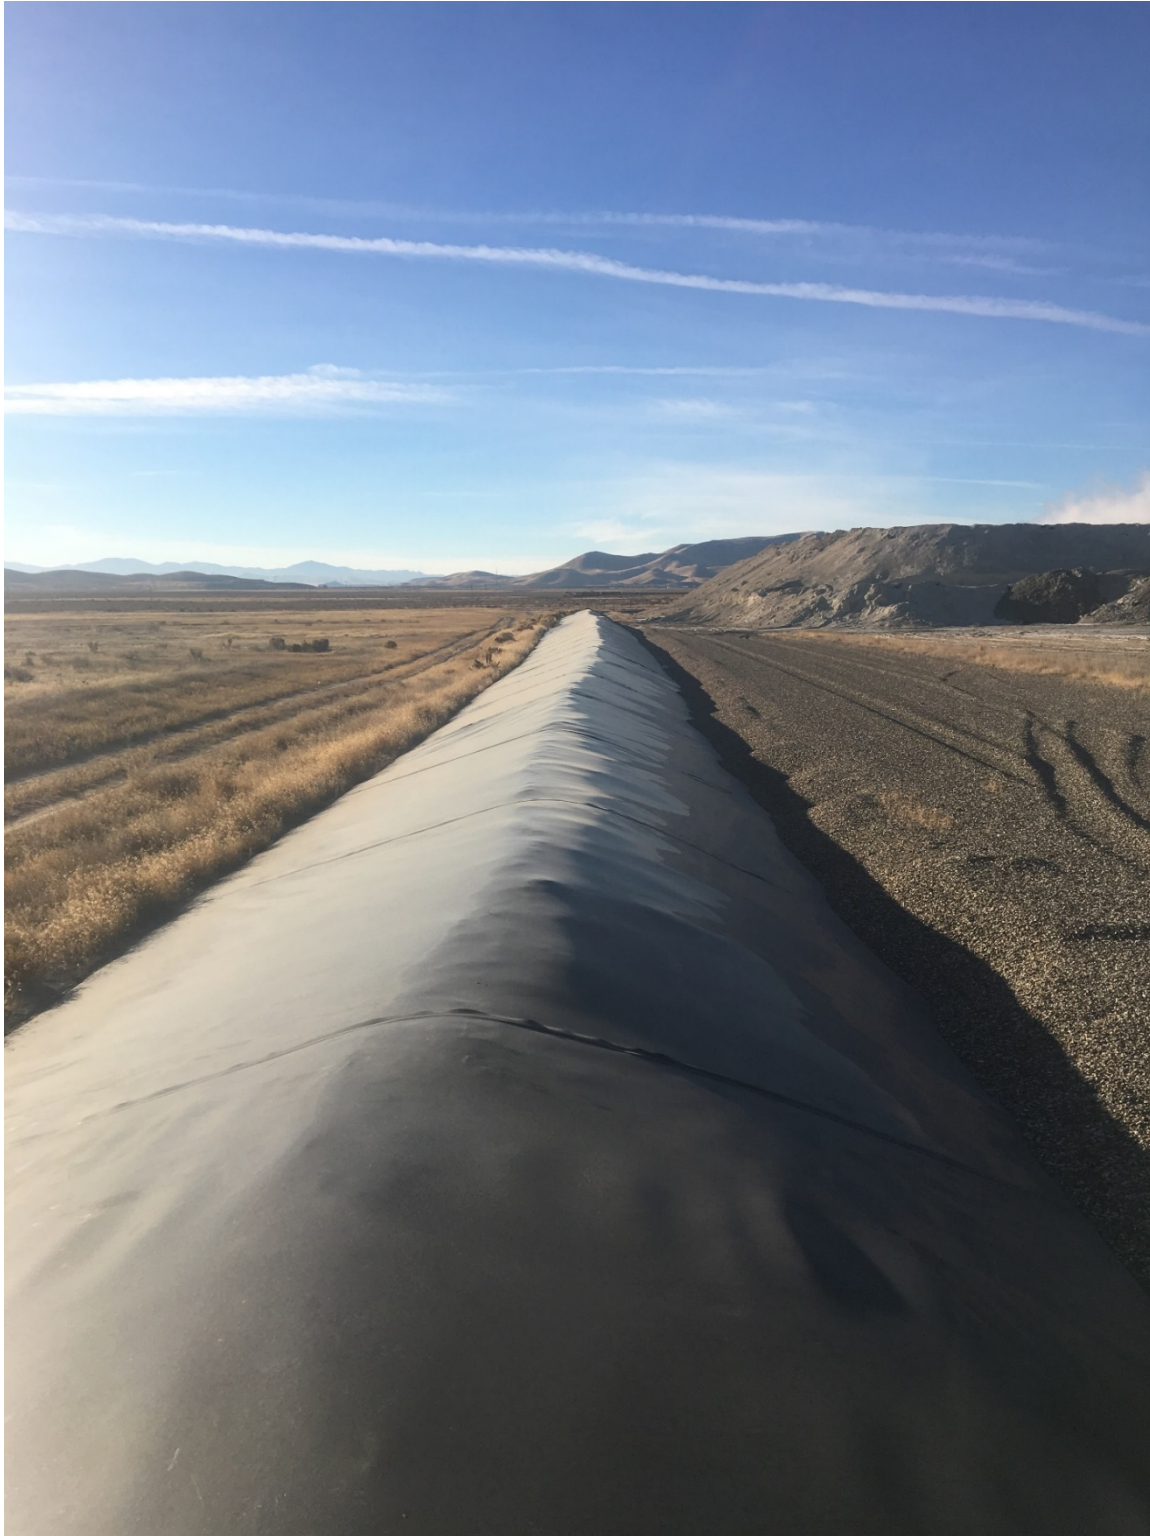
1.2 Evidence of Movement		X	See 1.1	
1.3 Evidence of Sloughing		X	See 1.1	Not in the constructed perimeter berms.
1.4 Evidence of Cracking		X	See 1.1	
1.5 Vegetation	X	X	7,8,9,10,11,14, and 15	Minor vegetation on the liner cover material

Photo 7. East Perimeter Berm, Northeast Corner, Cell 1 and 2 - View South

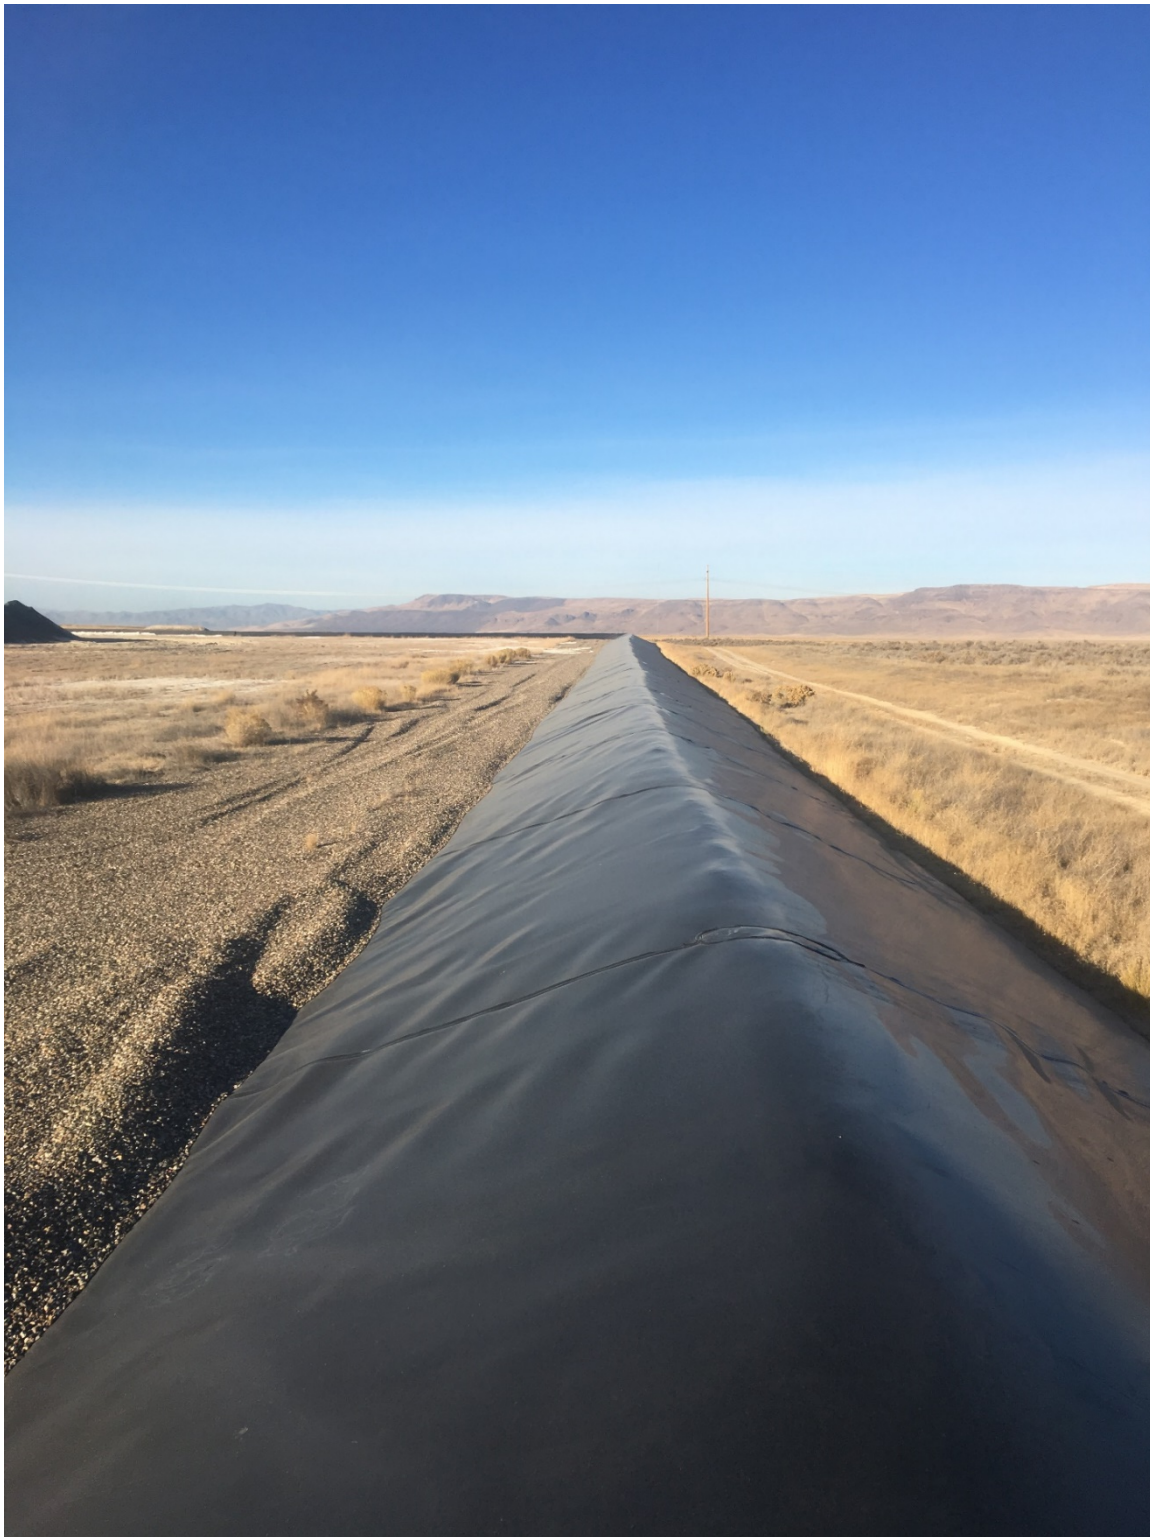
Photo 8. North Perimeter Berm, Northeast Corner, Cell 2 - View West

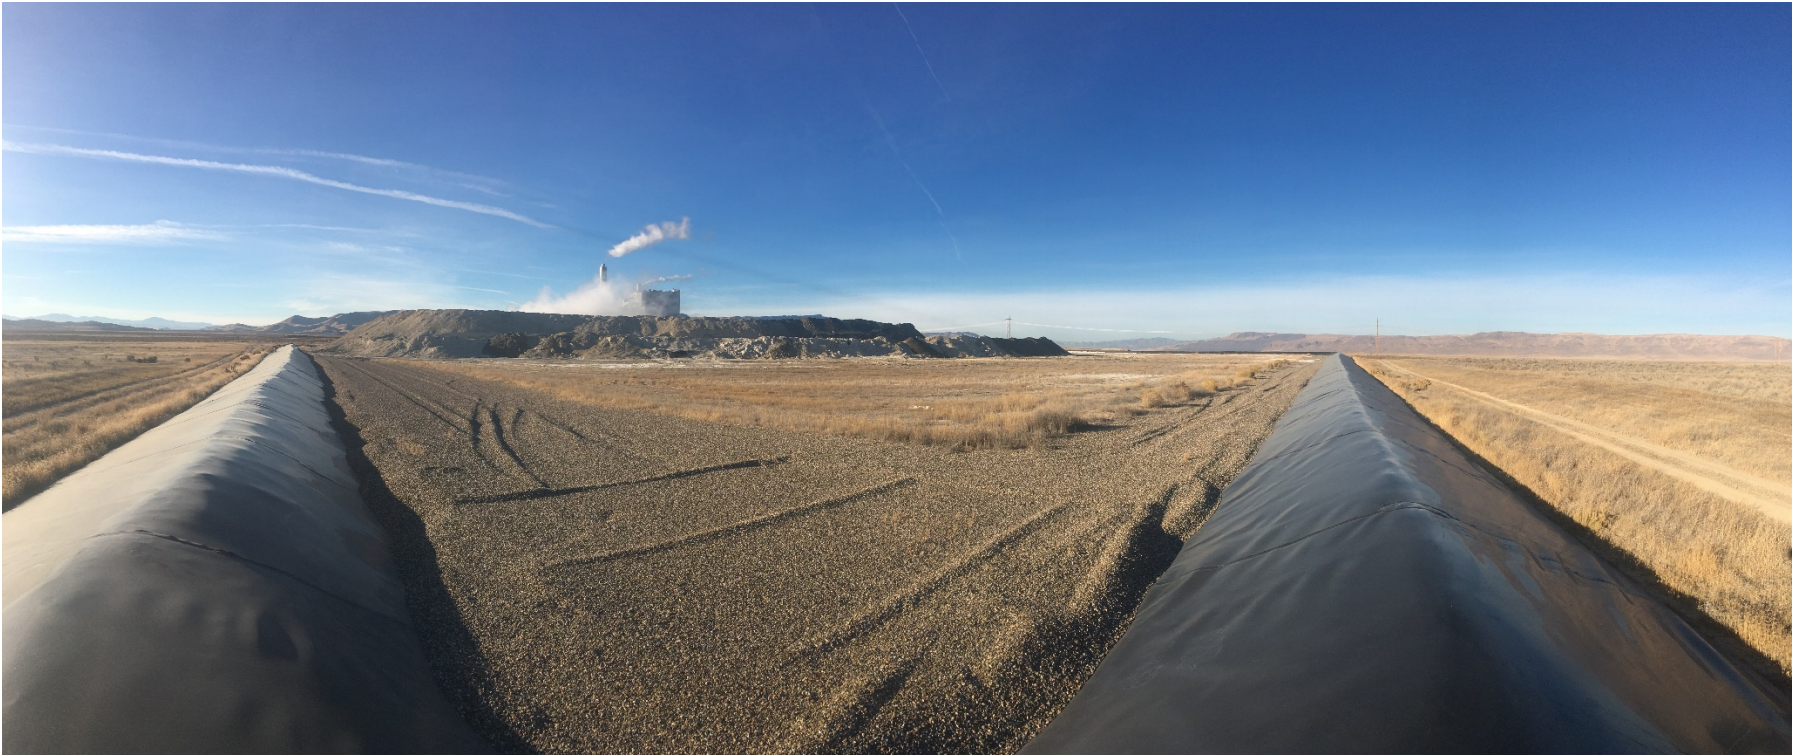
Photo 9. Northeast Corner of CCR, Cell 2 - View Southwest

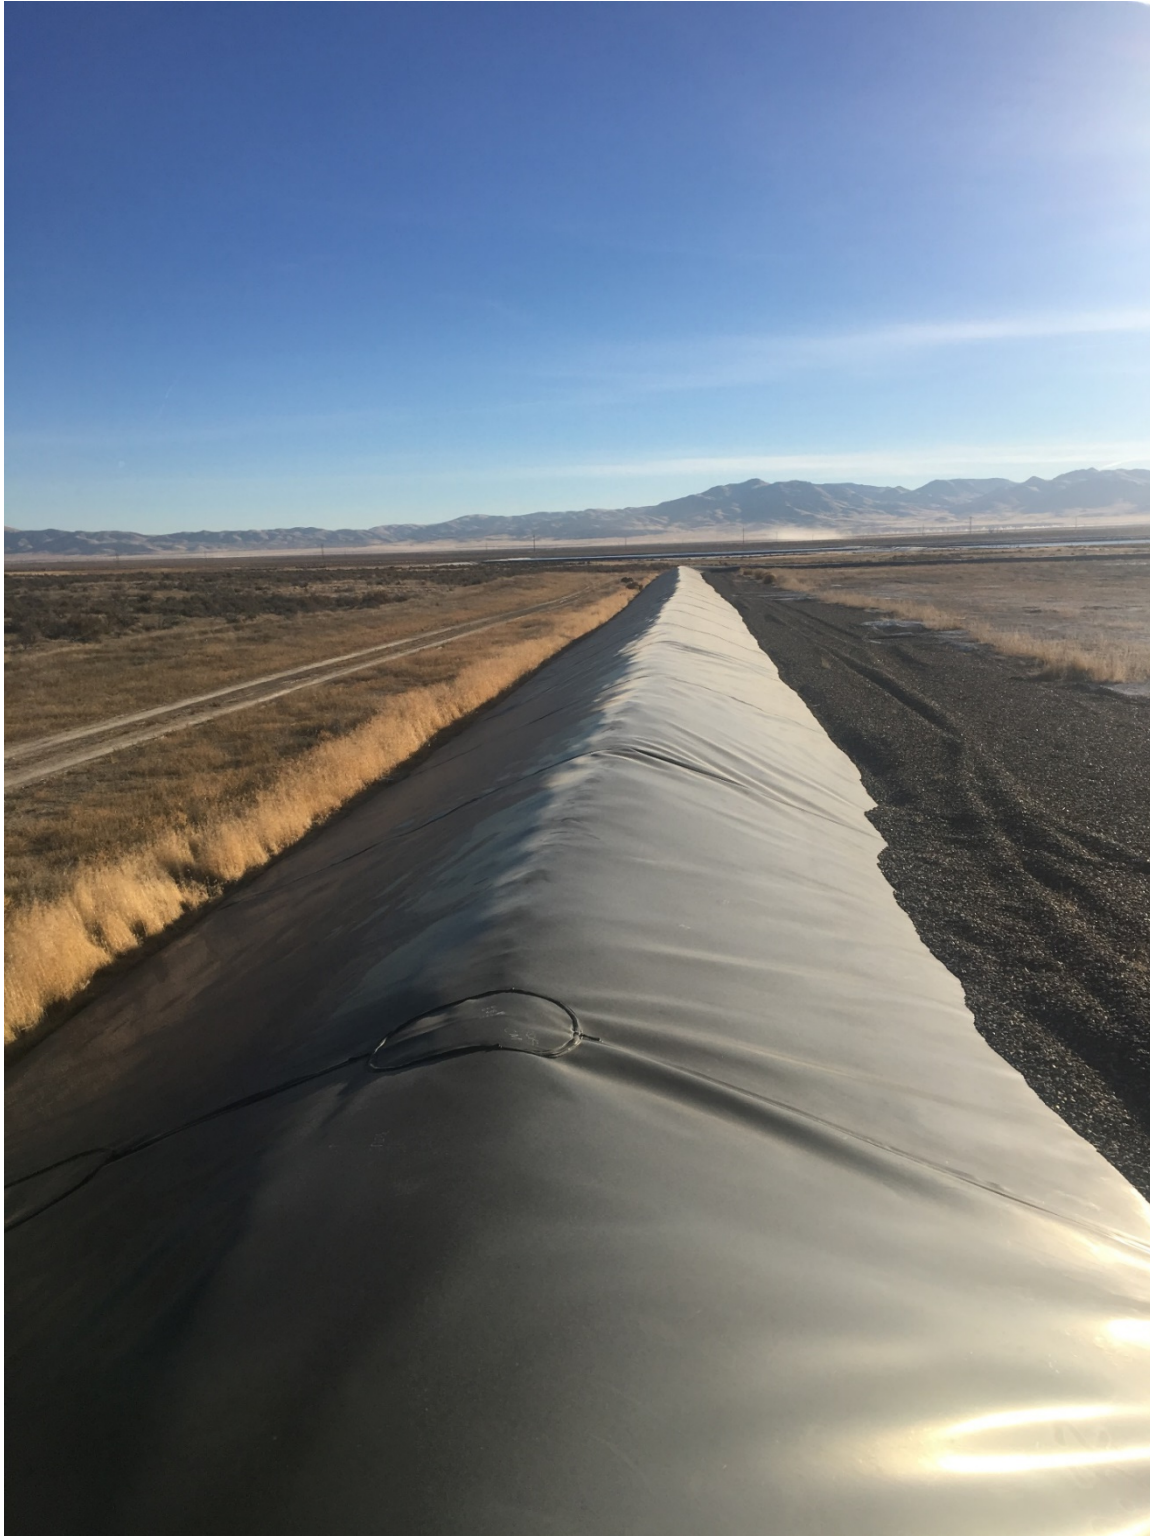
Photo 10. North Perimeter Berm, Northwest Corner, Cell 2 - View East

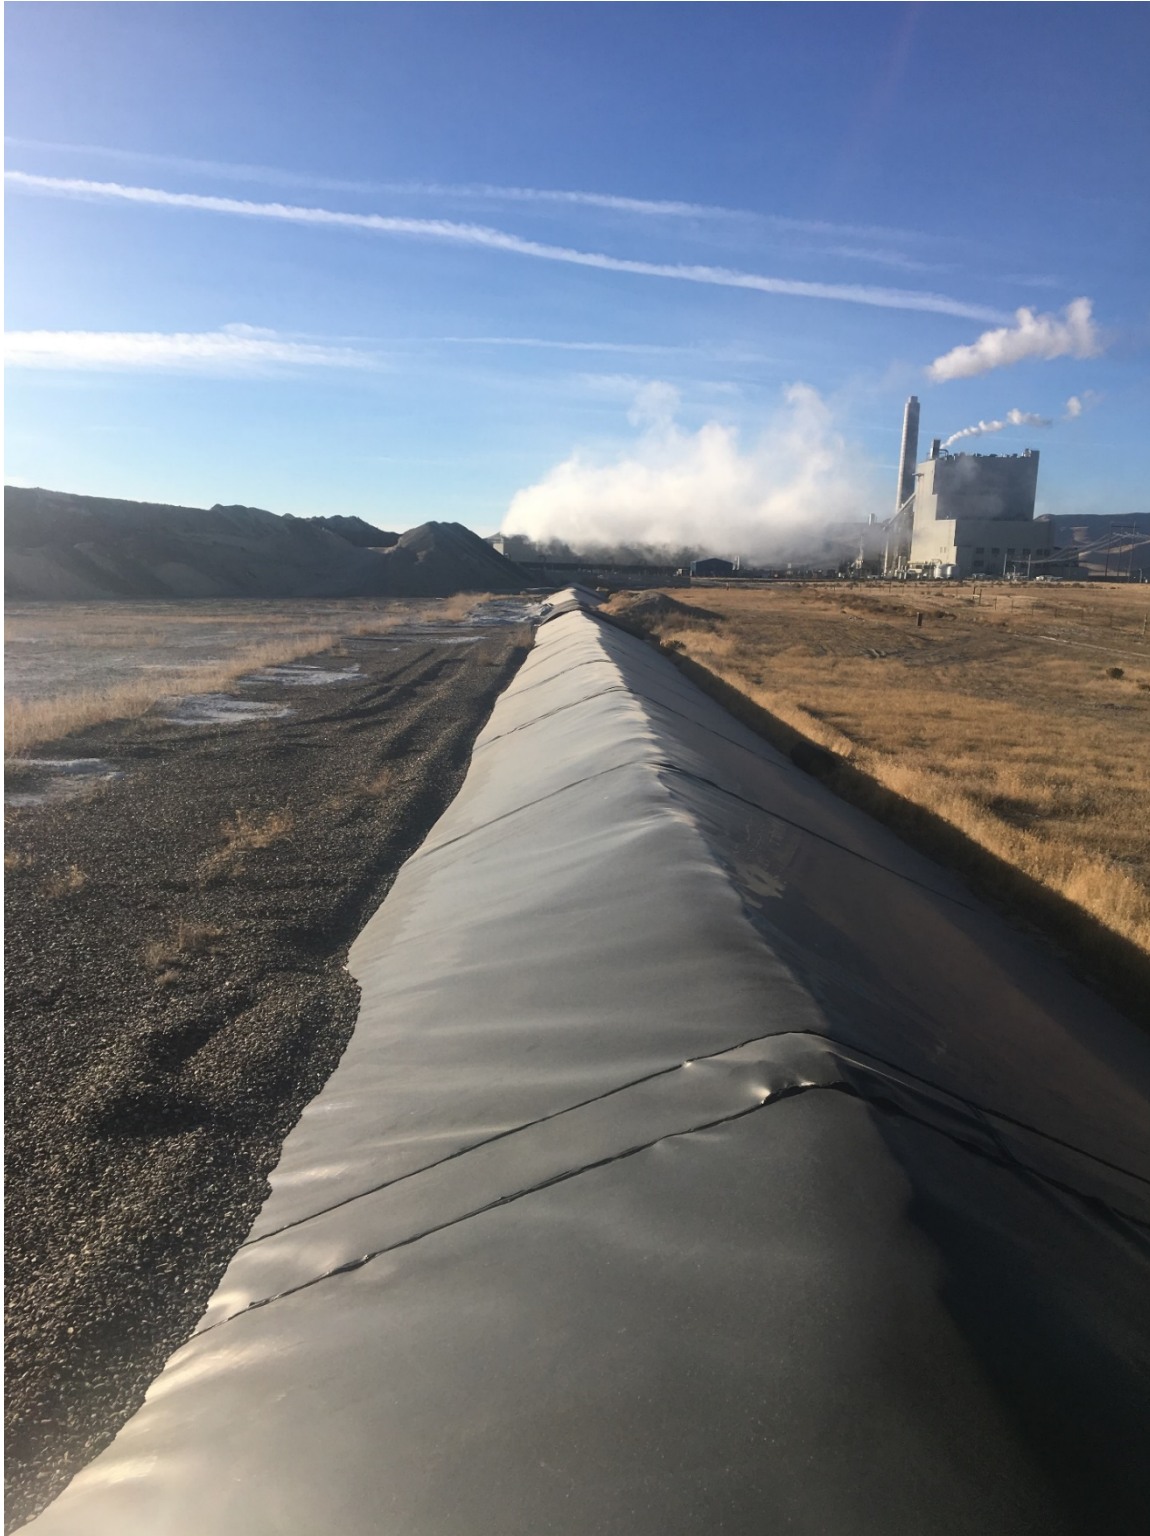
Photo 11. West Perimeter Berm, Northwest Corner, Cell 1 and 2 - View South

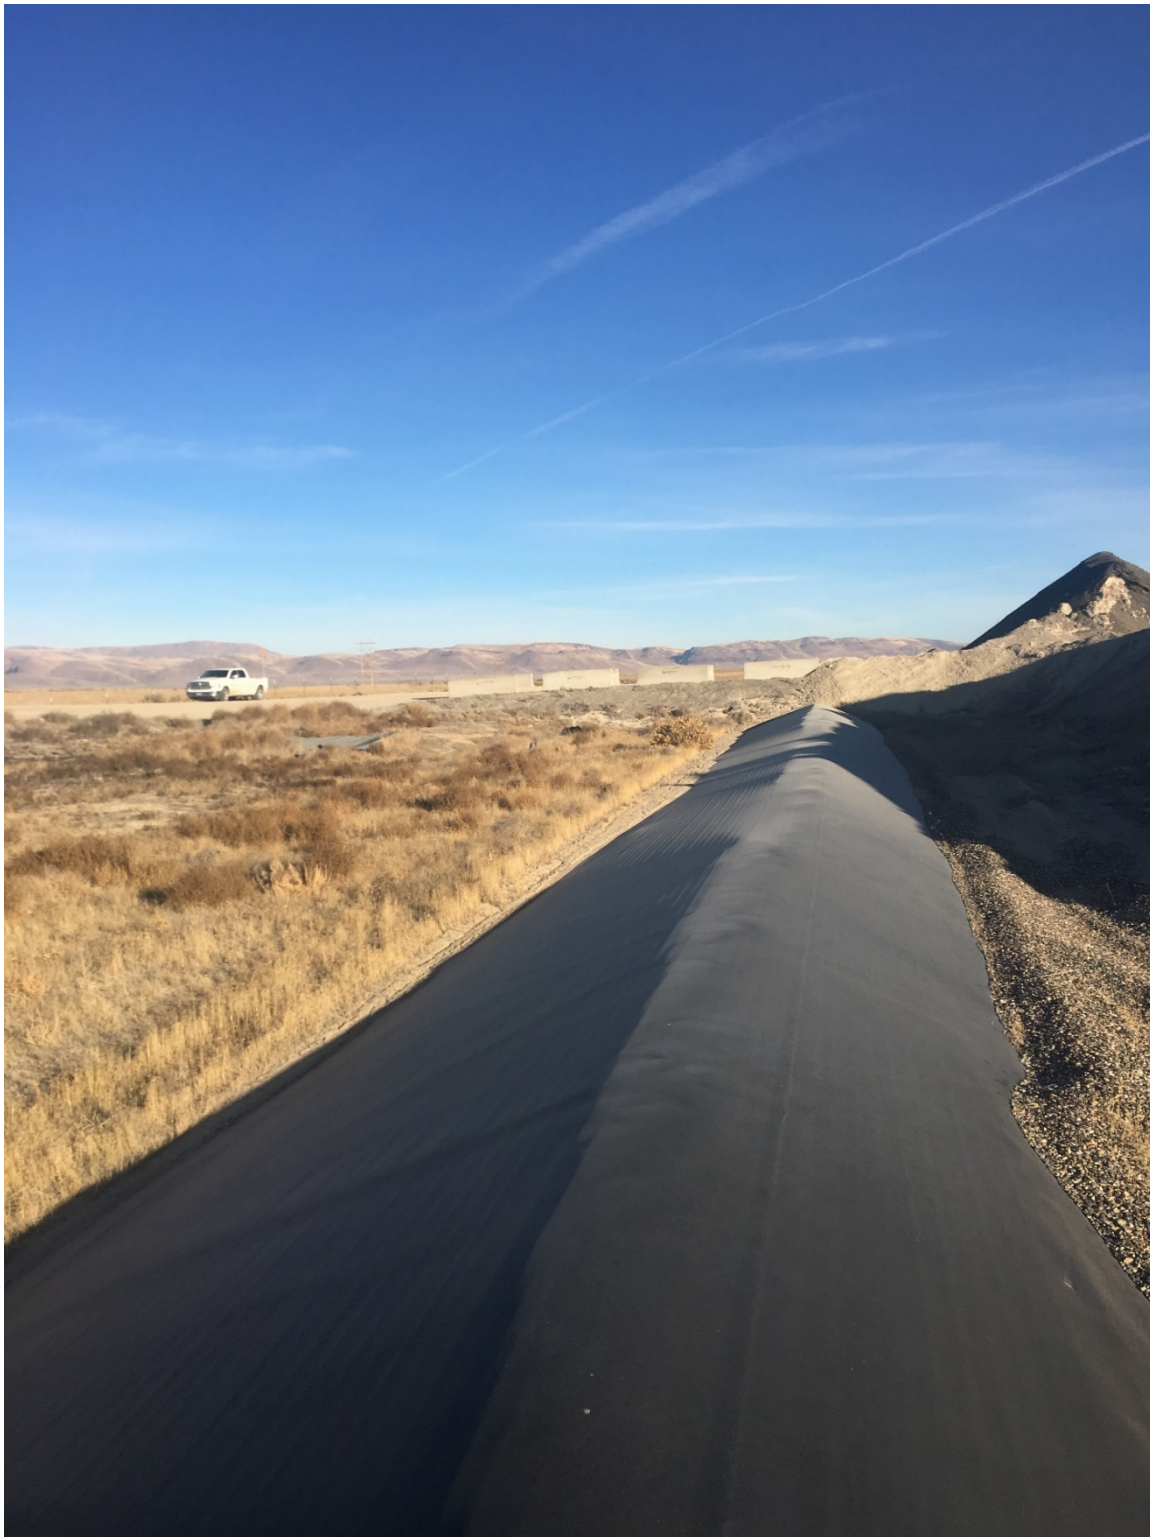
3.2 Embedded/buried structures		X		
3.3 Accessible by Truck	X		12	Landfill access ramp
3.4 Public Access		X	2, 3, and 4	Area fenced.
3.5 Other Unusual Conditions		X

Photo 12. North Perimeter Berm, Southwest Corner, Cell 1 - View North

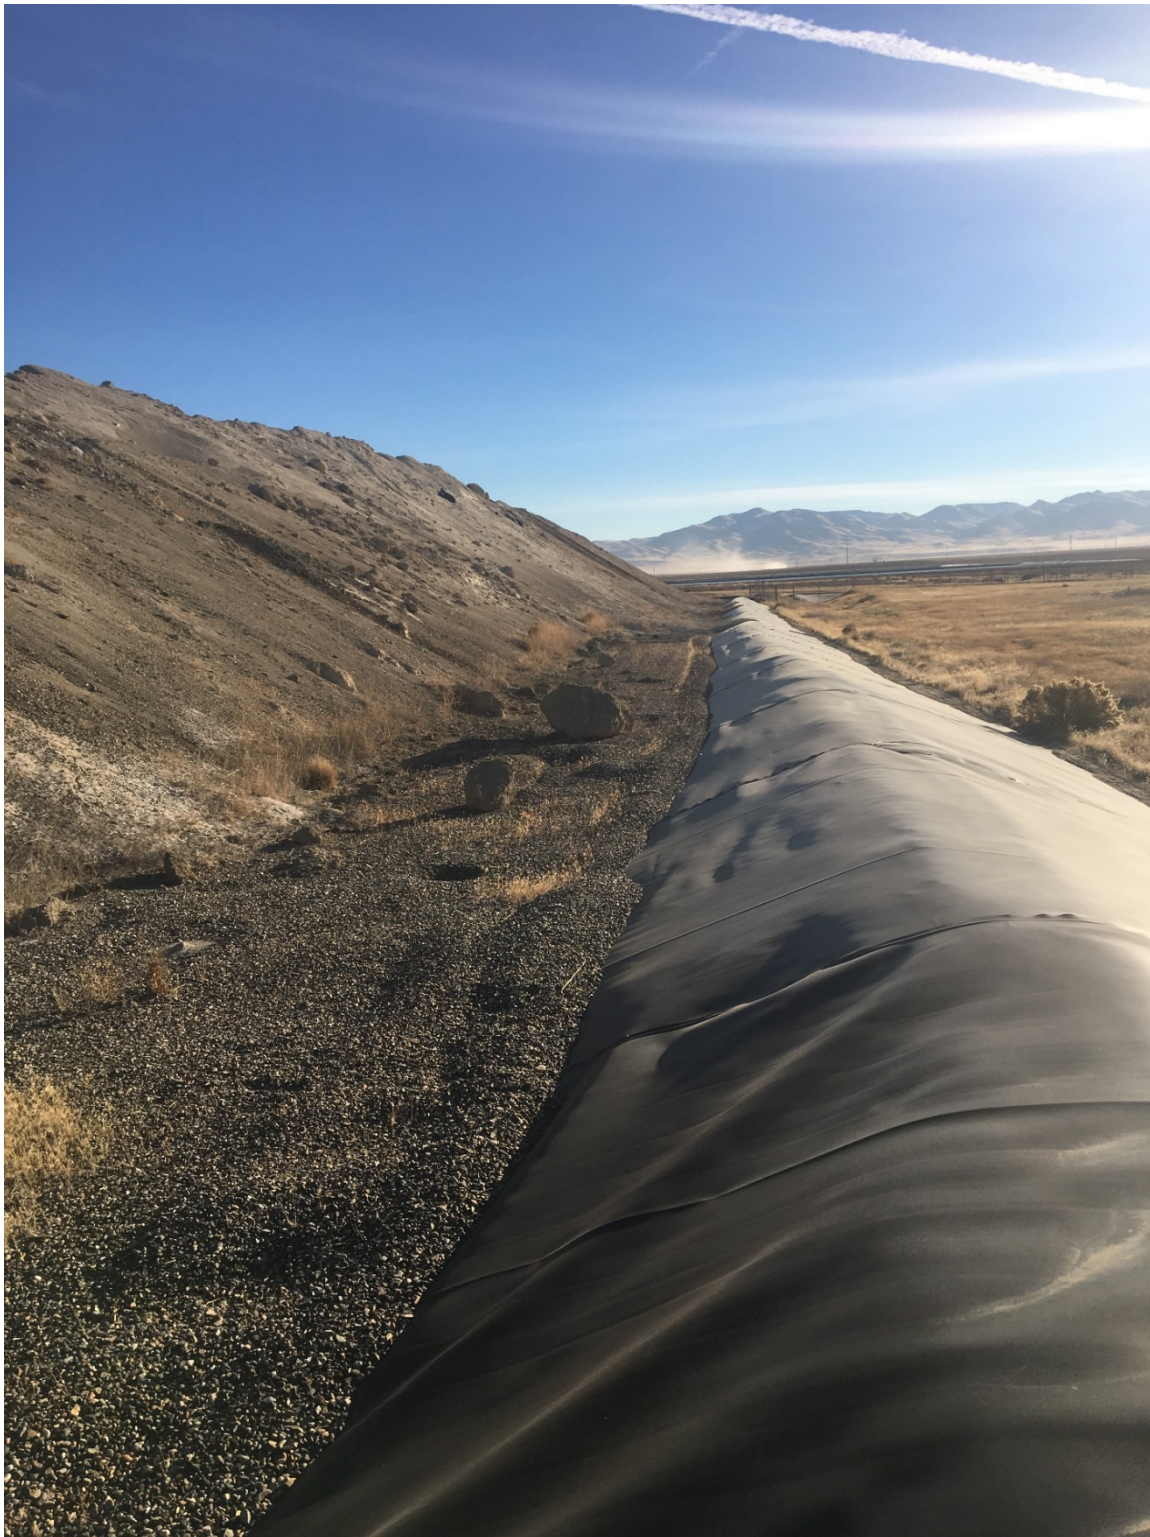
Photo 13. South Perimeter Berm, Southeast Corner, Cell 1 - View East

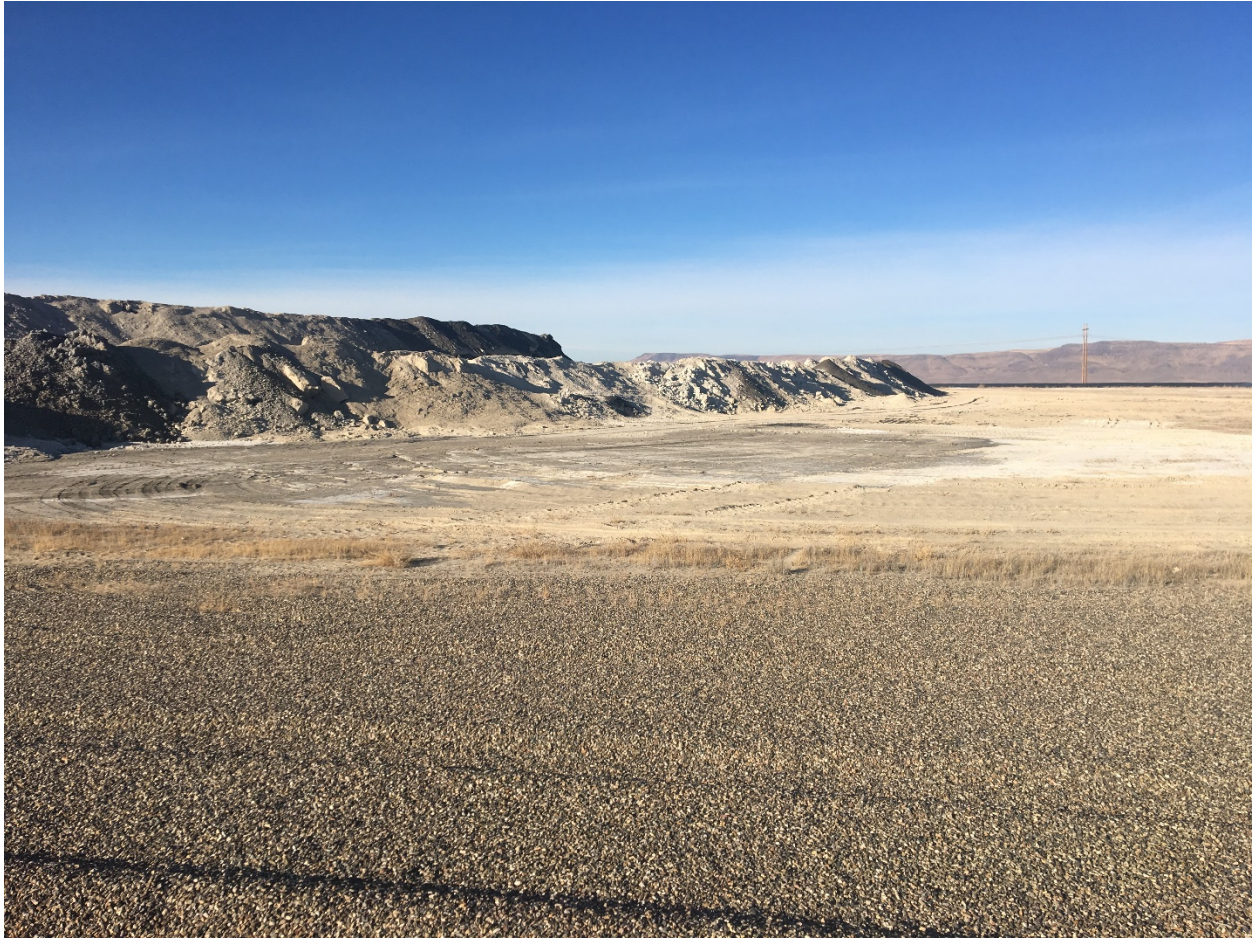
Photo 14. Cell 2 Deposition - View West

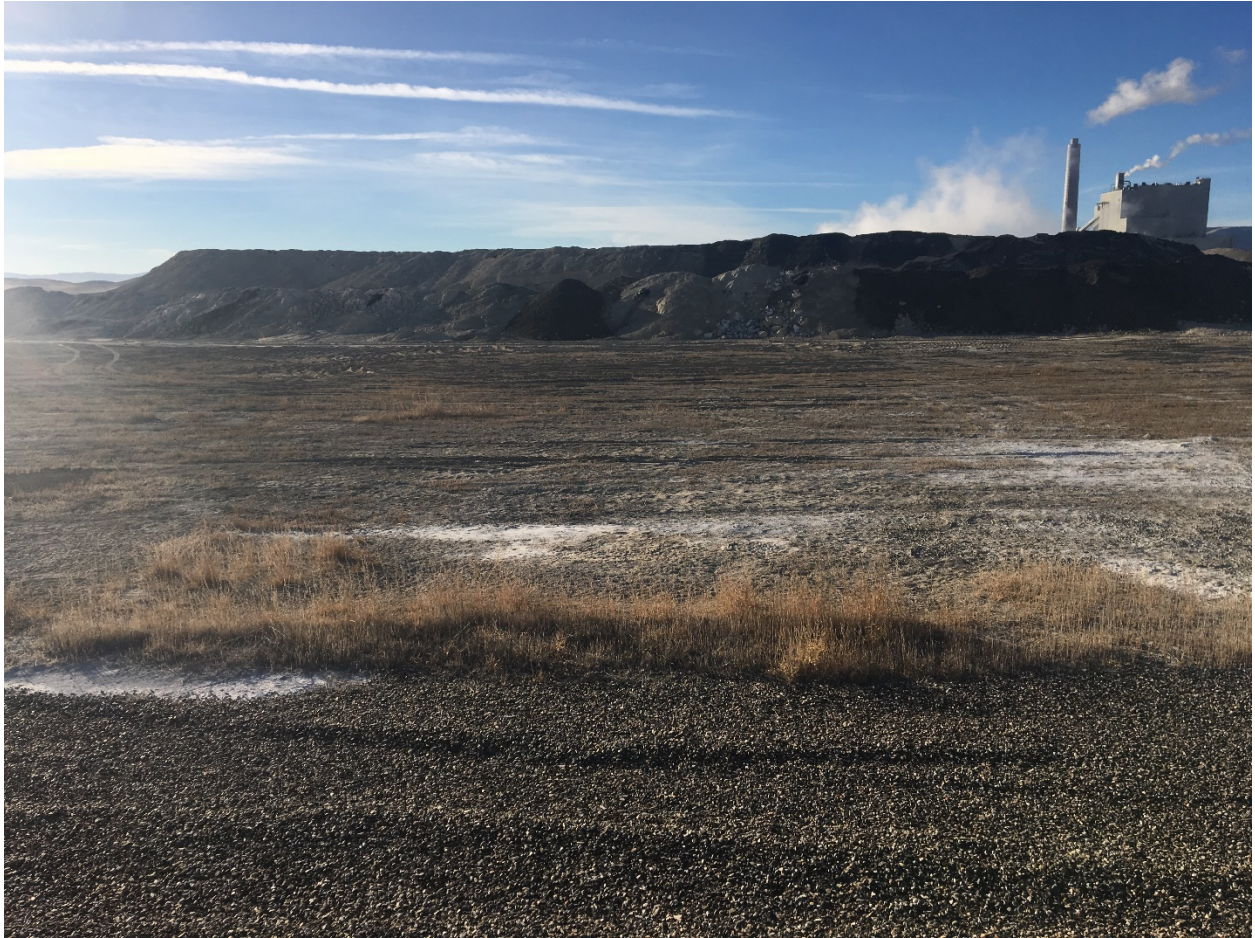
Photo 15. Cell 2 Deposition - View South
