RED CHRIS MINE

FALL OF GROUND INCIDENT 2025

Emergency Response, Investigation & Action Plan

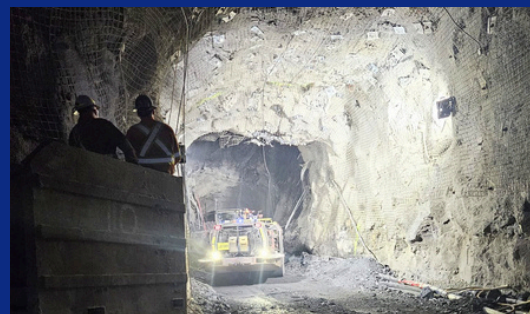
A crew removes more than ~2,500 tonnes of material from the decline using manual and remote-controlled scoops.

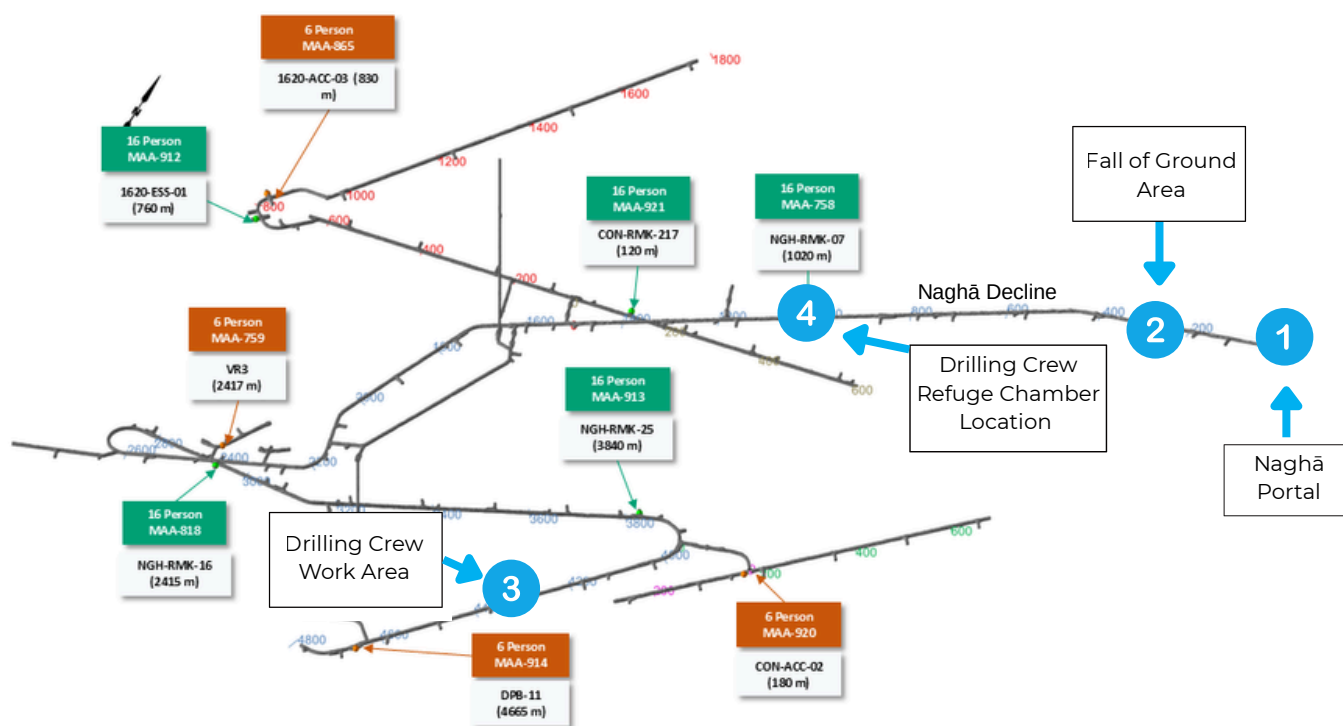
Diagram of Naghā Decline showing locations of (1) Naghā Portal, (2) fall of ground area, (3) drilling crew work area, and (4) drilling crew refuge chamber location (at Remuck 7) as well as the locations of eight other refuge chambers. Source: Newmont RCBC Quarterly Refuge Chamber Plan - July 2025.

- On July 22, 2025, at 6:40 am, a three-person contract partner drilling crew enters the Naghā Portal (1).
- During the next hour, an initial fall of ground occurs about 230 metres from the Naghā Portal.
- At approximately 7:47 am, a scoop operator discovers the initial fall of ground (2) which is partially blocking access to the decline.
- The operator notifies his supervisor and returns to the surface to prevent any other workers from entering the portal.

- The drilling crew is working in the decline more than one kilometre from the portal (3) at the time of the initial fall of ground incident.
- The crew is contacted by radio and instructed to shelter in a refuge chamber at Remuck 7 (4), one of nine underground refuge chambers. They arrive at 9:15 am and establish communications at 10:35 am.
- Geotechnical engineers inspect the fall of ground area and begin planning ground stabilization.
- At 11:24 am, more debris falls (~2,000 tonnes) in the same area, damaging communications, power, and air supply to refuge chambers.
