Traffic Study Newmont

Traffic Study Report [Final]

Project title: Traffic Study Newmont

Document: Traffic Study Report

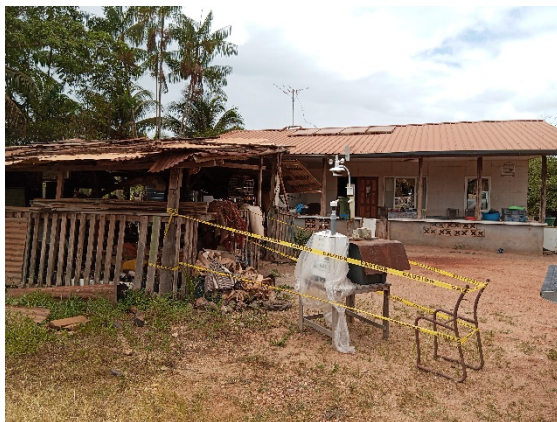
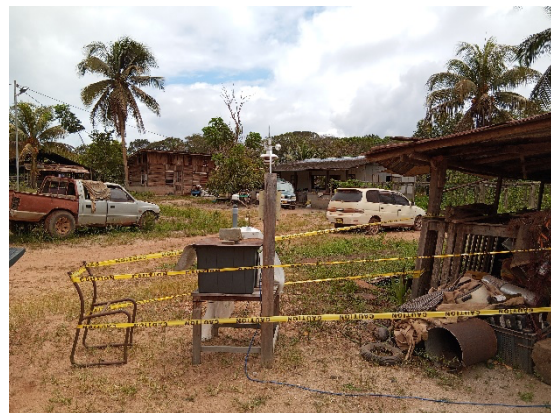
**Location D2**

The Areoqual-AQS-1 Dust Profiler (AQS-1) with MET-ONE (weather) station was installed at a resident located in Leewani Kampoe. The measurement was carried out from the 5th till the 13th of March 2024 (7 days continuously).

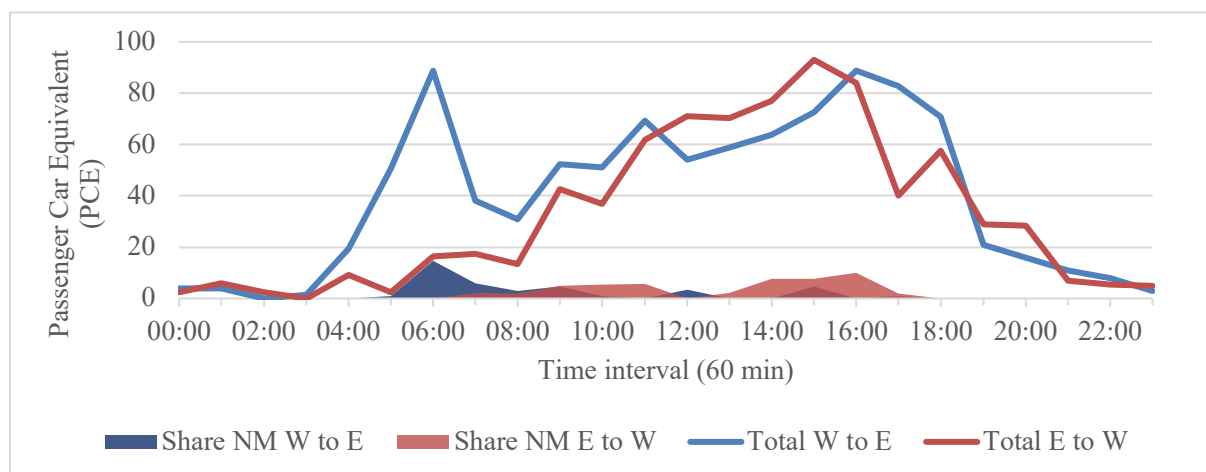
For traffic on the East-West Connection Road towards the East there is a sharp morning peak observed around 6:00 and in the afternoon there is a wider peak in-between 16:00 - 18:00. A small peak is observed around 11:00 in the morning. There is a sharp reduction of traffic after 18:00, with barely any traffic during the night, between 21:00 - 4:00. The majority of traffic passing by are passenger cars. There is a relatively large share of trailer- and heavy trucks between 5:00 - 7:00 in the morning going toward the East. Newmont's share of traffic in this direction is at least 17% in the morning peak and is mostly related to fuel, supply and employee buses.

For traffic towards the West there is no morning peak observed, however there is an afternoon peak around 15:00. There is a peak for buses towards the West around 15:00 and towards the East there are bus peaks around 6:00 and 13:00. Up to 15% of the hourly traffic towards the West is related to Newmont's operations in the morning and 10-12% in the afternoon peak.

Figure 12: Hourly traffic volumes in PCE for both traffic flows from West (W) to East (E) and East to West including the shares of Newmont (NM) related traffic for each direction.

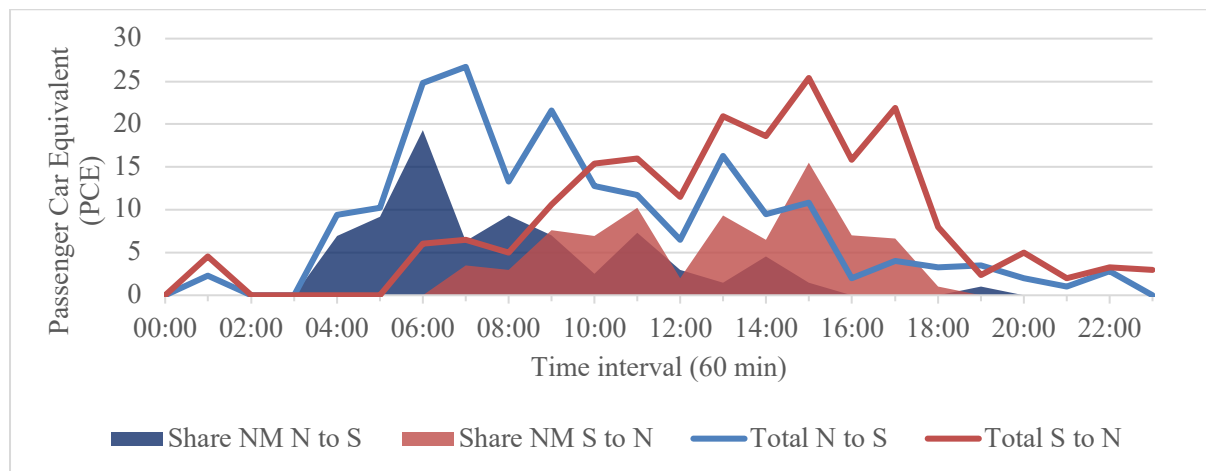
For traffic on the Road to Patamacca towards the South there is a morning peak observed around 6:00 – 7:00 with a small peak at 9:00 and in the afternoon there is a small peak at 13:00 with barely any traffic after 16:00. The majority of traffic passing by are passenger cars. There is a relatively large share of trailer trucks between 4:00 - 7:00 in the morning going toward the South. There is also a relatively large share of buses around 8:00-9:00, related to public transport and Newmont's personnel transport. Newmont's share of traffic in this direction is over 75% in the morning peak and is mostly related to fuel, supply and employee buses.

For traffic towards the North there is no morning peak observed, however there is a wide afternoon peak between 13:00-17:00. There are peaks for buses towards the North around 6:00, 8:00-9:00 and around 13:00-14:00. The latter two peaks are mostly related to students going towards and coming back from school. There is a relatively large share of trailer trucks going towards the North at 15:00. Up to 70% of the hourly traffic towards the North is Newmont's operations in the morning and 30-60% in the afternoon peak.

Figure 15: Hourly traffic volumes in PCE for both traffic flows from North (N) to South (S) and South to North including the shares of Newmont (NM) related traffic for each direction.

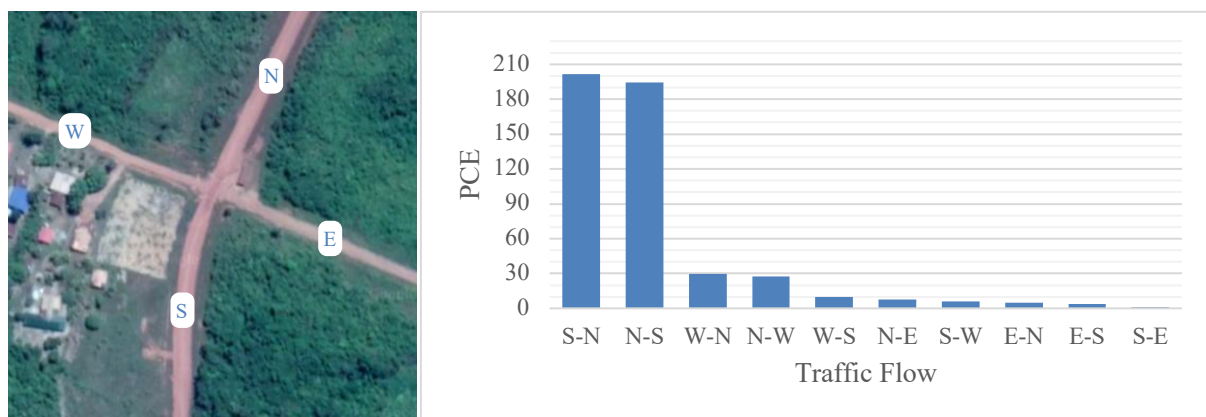
Figure 18 gives an overview of the daily traffic flows in PCE on the intersection. The majority of traffic flows from South to North (202 PCE) and North to South (195 PCE). There is a relatively large flow of traffic between Kraboe Olo and the North (28-30 PCE in each direction), but there is barely any traffic to and from Mora Kondre.

Figure 18: Daily traffic flows in PCE on the intersection of the Road to Patamacca with Kraboe Olo (W) and Mora Kondre (E).

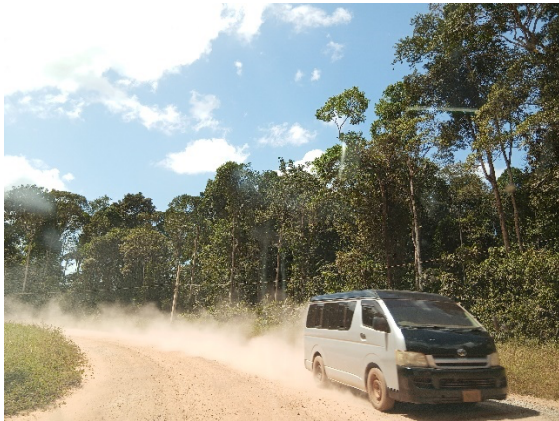
Dust plume caused by car

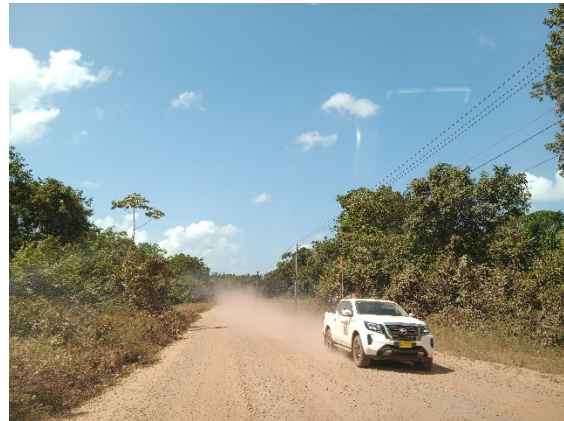
Dust plume caused by light truck

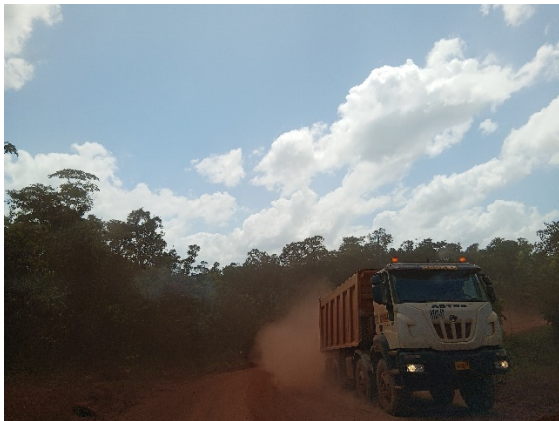
Dust plume caused by heavy truck

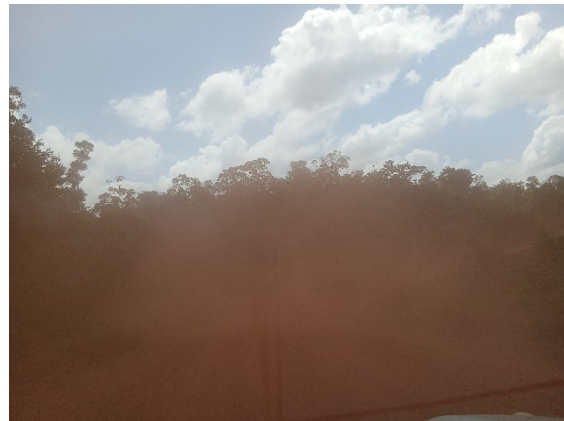
Dust cloud

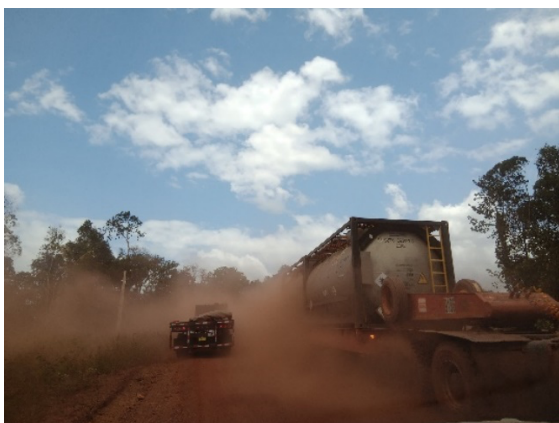
Dust plume observed by two heavy trucks passing by each other

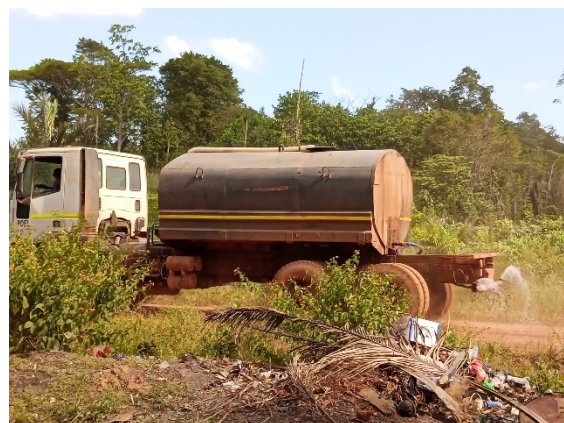
Water tanker truck observed spraying water on the laterite (unpaved) Patamacca Road

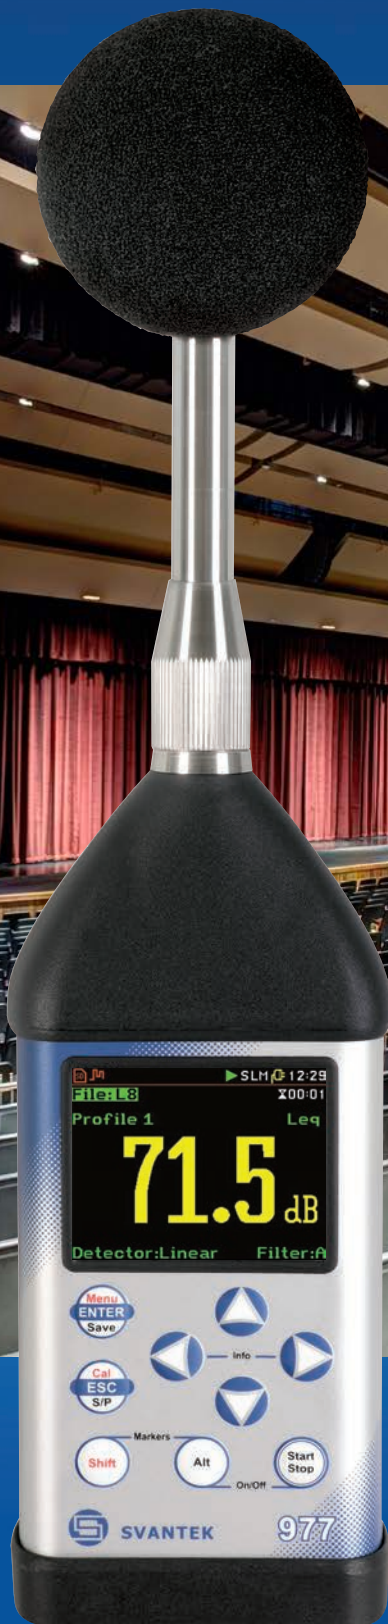
SVAN 977C Sound & Vibration Level Meter

SVAN 977C Class 1 **SOUND & VIBRATION** Level Meter and Analyser is designed to meet the needs of both environmental monitoring and occupational health and safety monitoring specialists.

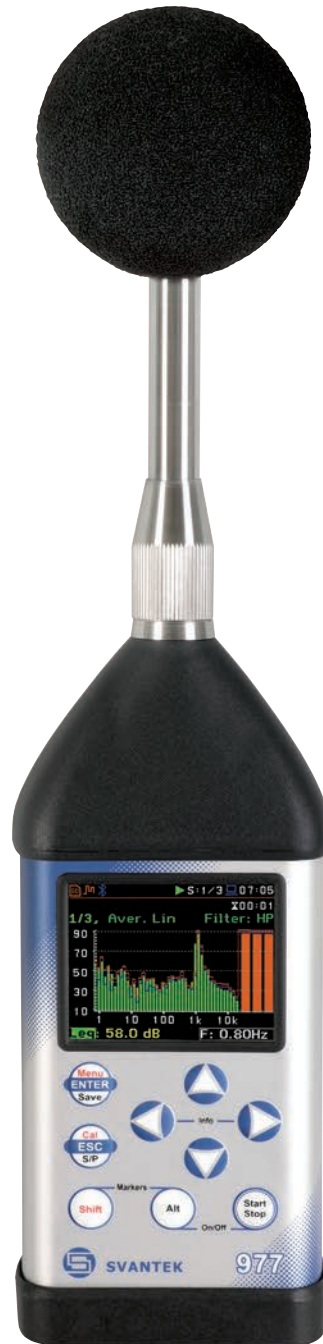
The **Bluetooth®** interface connects the meter with the Building Acoustics Assistant and SvanMobile application that allows the user to trigger measurements, edit settings, rename files and view the results remotely.

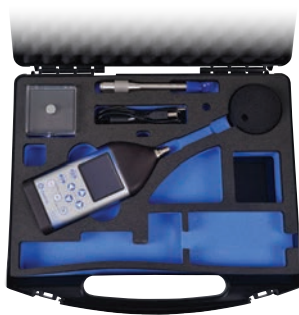
SV MK202E
Ultrasound
Microphone up to
40 kHz band

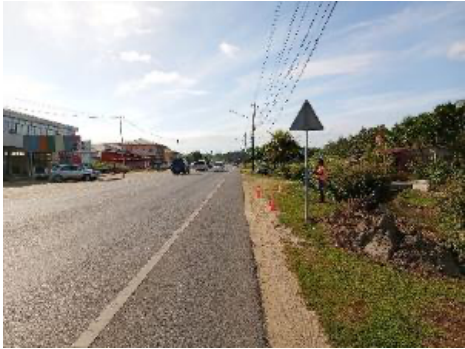
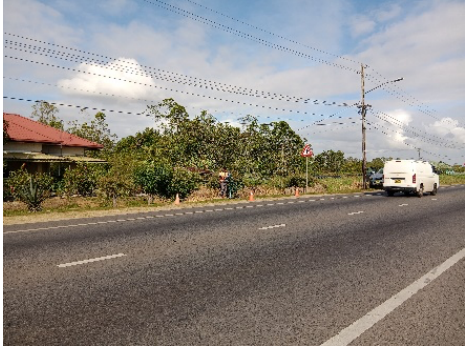
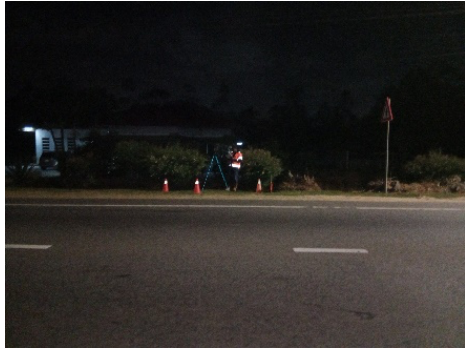
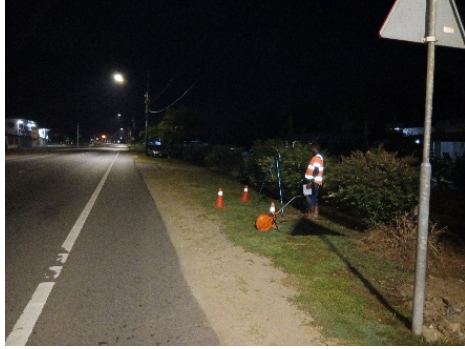
Daytime (5 March 2024)	Nighttime (27 - 28 February 2024)
Location N1: At the berm in front of a resident in Meerzorg, along East West Connection Road. There was a gutter between the fence of the resident and the berm.

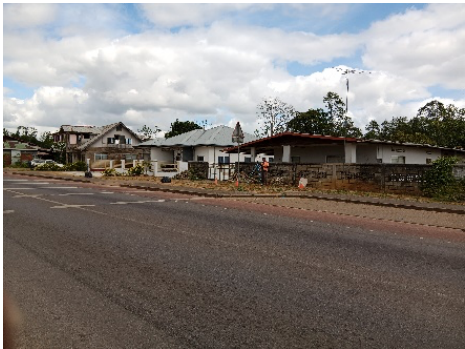
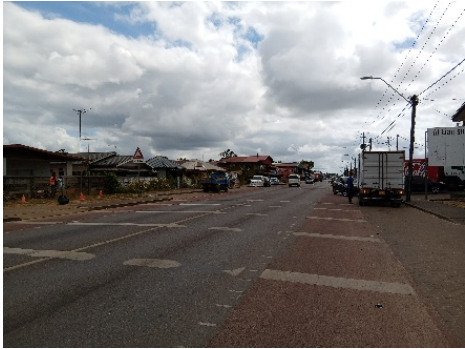
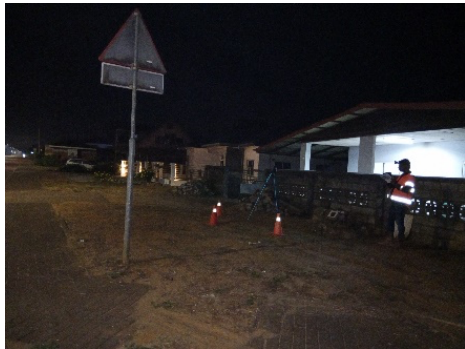
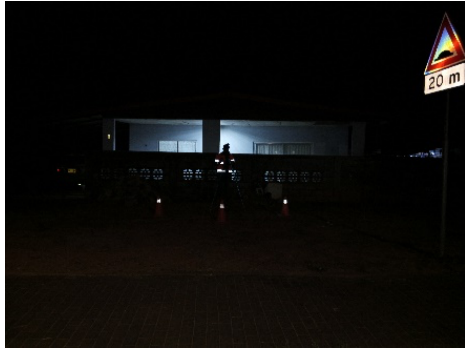
Location N2: At the berm in front of the fence of a resident in Tamanredjo, along East West Connection Road.

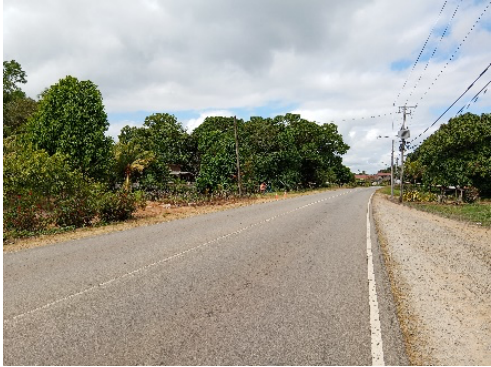
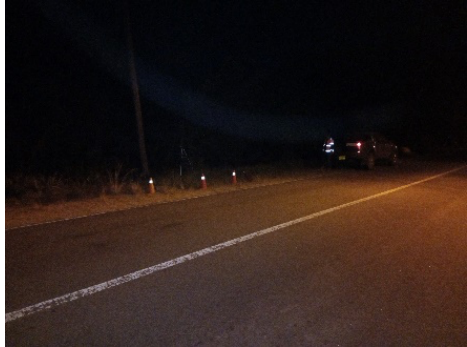
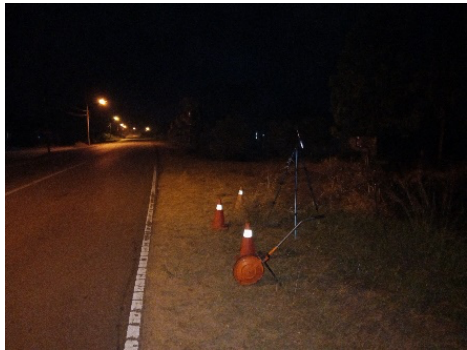
Daytime (5 March 2024)	Nighttime (27 - 28 February 2024)
Location N3: At the berm in front of a resident in Orleane Kreek, along the East West Connection Road.

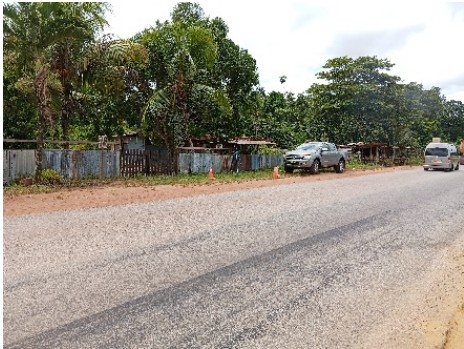
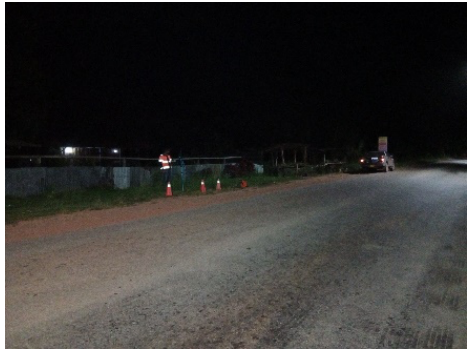
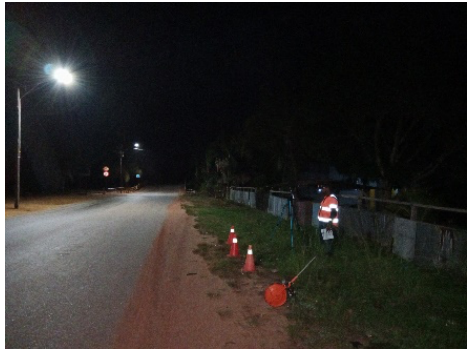
Location N4: At the berm in front of a resident at Stolkertsijver, along the East West Connection Road.
