**DECEMBER 2017 INSPECTION
CCR LANDFILL
TS POWER PLANT**

Newmont Nevada Energy Investment, LLC
914 Dunphy Ranch Road
Battle Mountain, Nevada 89820

NewFields Project 475.0221.003
January 2018

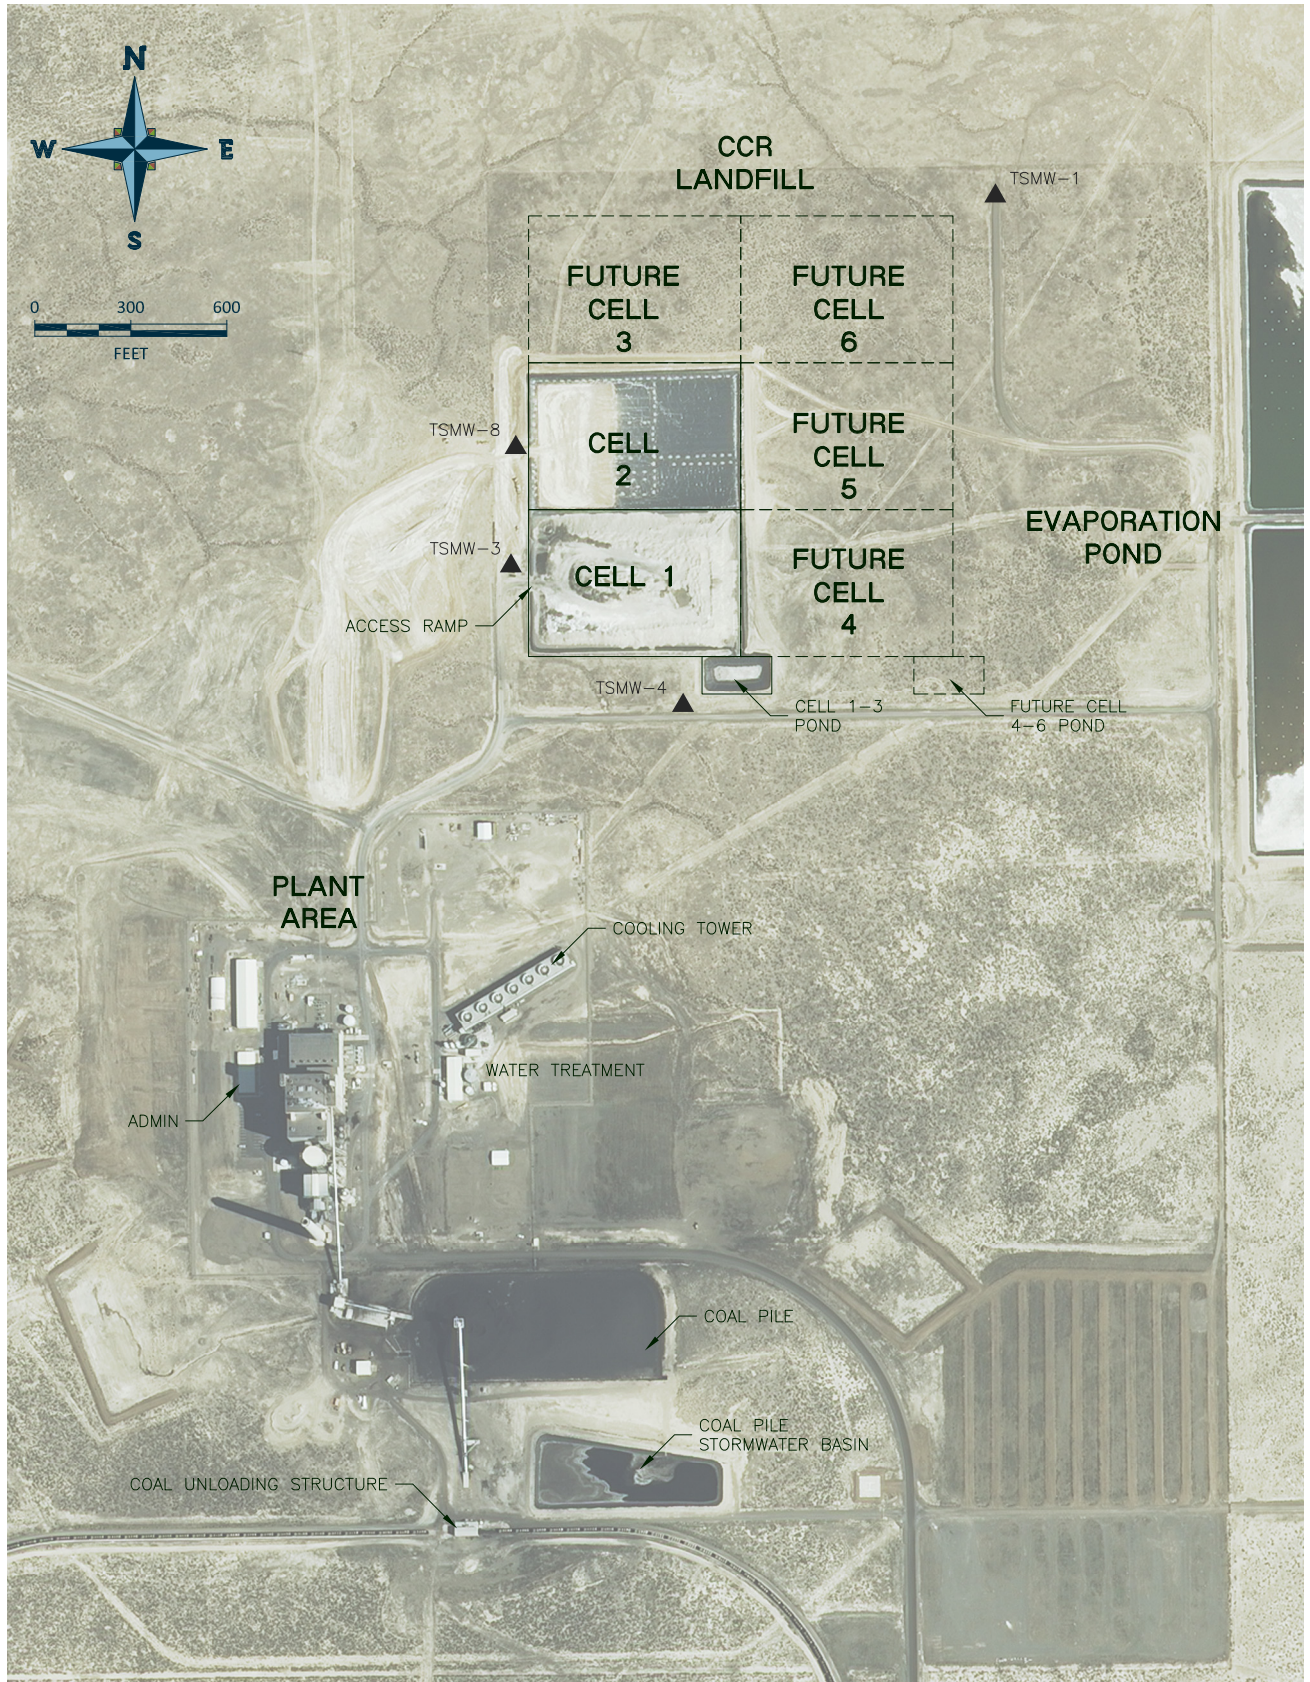
AREA	TS POWER PLANT	CLIENT	NEWMONT
		PROJECT	DECEMBER 2017 INSPECTION CCR LANDFILL		
PROJECT NUMBER	LOCATION	FIGURE TITLE			
475.0221	EUREKA COUNTY, NEVADA	GENERAL SITE PLAN			
DOCUMENT FILENAME		FIGURE NUMBER	REVISION		
TSPP-221-10K-0002_0.DWG		2	0

Inspected by:	Kerry A. Magner, P.E.
Approved and reviewed by:	Kevin Lutes, P.E.
Inspection Date:	December 14, 2017
Weather conditions:	Sunny, light winds and cool
Purpose of facility:	Storage of CCR and cooling tower side stream softening filter press sludge.
Date of last Facility Inspection by the EOR:	N/A
Date of last Facility Inspection Report:	December 2016
Initial construction date:	Cell 1 - 2008 and Cell 2 - 2013
Original facility engineered by:	AMEC (2005)
Type of facility:	Non-Impounding landfill. Fully geomembrane lined with 80-mil HDPE. External stormwater/leachate collection pond lined with 80-mil HDPE over GCL.
Watershed:	The up gradient watershed is collected and routed to the east and west via stormwater diversion channels.
Monitoring:	Four groundwater monitoring wells in the area surrounding the landfill. Three down gradient and one up gradient a shown on Figure 2.
Design/as-built data available:	Yes. On-site.
