RED CHRIS MINE

FALL OF GROUND INCIDENT 2025

Emergency Response, Investigation & Action Plan

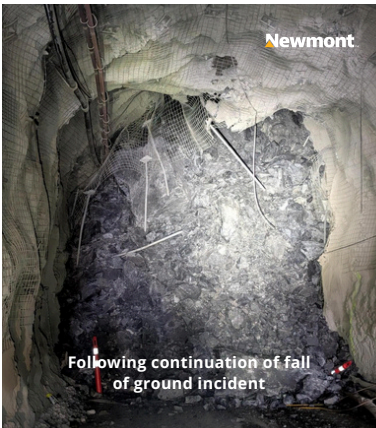
Of critical importance to the investigation was to understand why the rock failed beyond the capacity of the installed ground support, which consisted of 2.4 m MD bolts, mesh, and fibrecrete (FRS). Investigators would also try to determine why there was no indication of deterioration of the installed ground support prior to July 22, 2025.

- 1 Time-dependent deterioration of the rock mass over four years increased loads on the ground support system, causing surface support overload and friction-type bolt failures. This led to unravelling of loose material.

- 2 The continuation of the fall of ground occurred because highly fractured rock was left unsupported after initial ground support damage.
- 3 Certain approaches taken during the construction of the decline in 2021 by Newcrest, the previous operator of Red Chris, fell short of Newmont's industry-leading standards:

- The rock mass classification system used during development (Bieniawski RMR89) lacked a stress reduction factor, leading to overestimation of ground quality. A post-incident investigation using the Norwegian Geotechnical Institute (NGI) Q classification system resulted in a reclassification of ground quality.

- Limited geotechnical oversight and standards resulting in ground support that did not account for actual conditions such as increased excavation size and limited testing and quality assurance (QA)/quality control (QC) on ground support performance.

- 4 Newmont has identified and committed to a series of corrective actions to prevent similar occurrences at the Block Cave Project, ensure that excavated areas meet Newmont's standards, and align all future excavation and work associated with those standards. This includes a re-assessment of installed ground support and the installation of additional or alternate ground support based on that reassessment.
